DDASaccident305

Humanitarian Demining Accident and Incident Database
AID

DDAS Accident Report

Report date: 19/05/2006	Accident number: 305
Accident time: 11:20	Accident Date: 25/10/1999
Where it occurred: Suleimanya province, Sharbazher district, Mawat sub-district, Bazaro village	Country: Iraq
Primary cause: Unavoidable (?)	Secondary cause: Inadequate equipment (?)
Class: Excavation accident	Date of main report: [No date recorded]
ID original source: ET	Name of source: ET/AVS 2001:KI02
Organisation: Name removed	
Mine/device: PMN AP blast	Ground condition: dry/dusty grass/grazing area metal fragments
Date record created: 19/02/2004	Date last modified: 19/02/2004
No of victims: 1	No of documents: 1

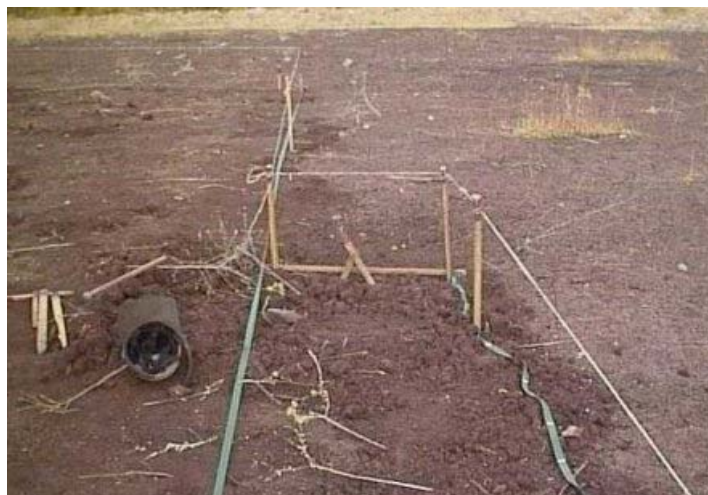
The picture below shows the accident site with the victim's helmet and visor lying at the side of the lane.

The accident occurred in a minefield called Palkie that was laid in 1970s. The area was heavily contaminated with metal as a result of shelling during the Iraq-Iran war. The contamination was such that a metal detector could not be used in some places and a "clearance by excavation" method was used.

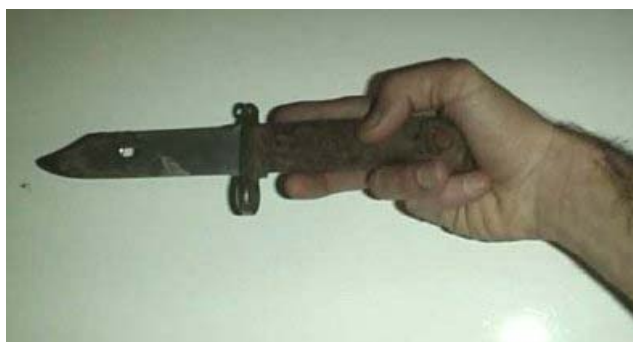
In one place where a shell had dropped, the victim was excavating using a Russian bayonet when he initiated a mine. The picture below was provided by the demining group and shows how the victim was holding his bayonet at the time of the accident.

The mine was an Iraqi PMN that had been 5cm under the ground surface. The demining group reported that these mines were known to be very sensitive, requiring only a small pressure to be activated - especially when they had been under the ground and exposed to water from rain for a long time. The picture on the right was provided by the demining group and shows how the victim was holding his bayonet at the time of the accident.

Fortunately only the booster of the mine detonated "as the main charge was expired".

The provision of inadequate and unsafe hand tools is a responsibility of management and the failure to do so is a “*Management/control inadequacy*”.

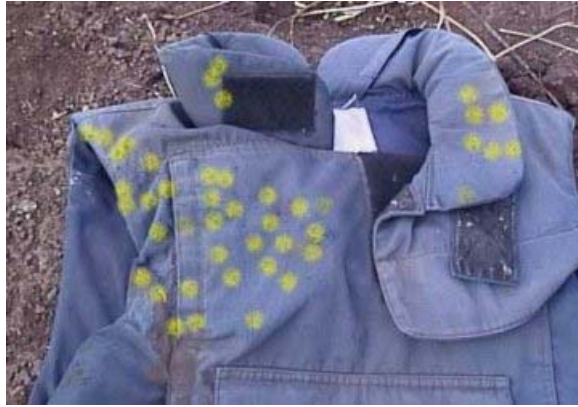
The victim's visor and flak jacket protected the covered parts very well. The yellow spots on the picture below show where the fragments struck the victim's frag-jacket.

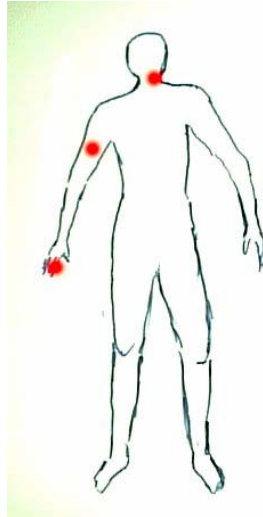
“Right hand with traumatic amputation of the tip of index finger; Burning injury on the upper part of the right arm; Bruising injury on the neck; Right hand, fracture on the base of the first metacarpal”.

The sketch of the victim’s injuries shown below was provided.
