DDASaccident309

DDAS Accident Report

Report date: 19/05/2006	Accident number: 309
Accident time: 10:45	Accident Date: 13/09/2000
Where it occurred: Nr Haji Mamand village, Barzinja Sharbazher district, Suleimaniyah Governorate	Country: Iraq
Primary cause: Other (?)	Secondary cause: Management/control inadequacy (?)
Class: Excavation accident	Date of main report: 20/09/2000
ID original source: JW/JDG/BK	Name of source: UN/JJ/ELS
Organisation: Name removed	
Mine/device: Type 72 AP blast	Ground condition: rocks/stones route (verge)
Date record created: 19/02/2004	Date last modified: 19/02/2004
No of victims: 3	No of documents: 2

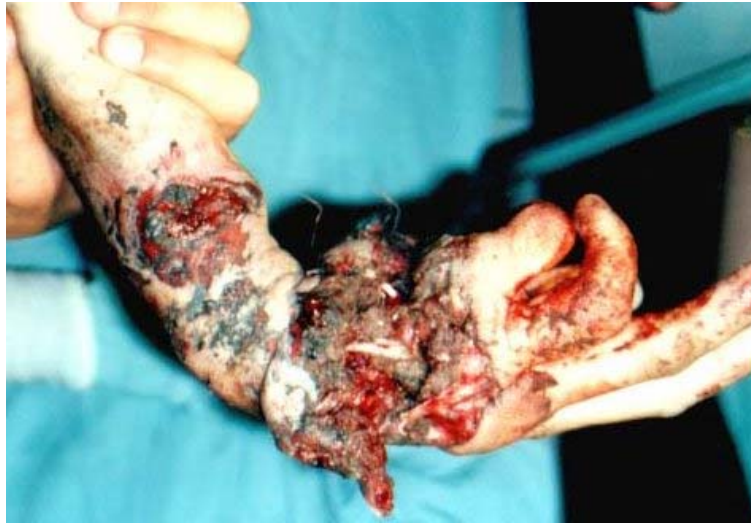
Victim No.1 suffered “facial burn/blast injuries (superficial) as well as fragment (Plastic) to his right eye socket which was removed by the eye doctor who treated him. The piece of plastic was probably from the Type-72 mine: Left hand thumb amputated/severed completely, index finger injured and amputated/ severed partially, middle finger second bone broken and injured badly, lacerations on back of hand and multiple cuts on inside (Palm).”

The picture of the victim's hand reproduced below was sourced elsewhere.

45. There were blast/black burn marks, coming from a typical explosive detonation, to the gloves as well as to the injured hand of [Victim No.1], indicating that his hand must have been

in very close proximity, if not in direct contact with the exploding mine. The markings observed on the piece of the trowel that was found indicate the typical explosion ricochet-burn markings as well as "melt/spotweld" markings. These confirm that the trowel was in very close proximity, if not in direct contact with the explosion for such high heat generating to cause the "melting/spotweld markings".
