### DDASaccident309

*Humanitarian Demining Accident and Incident Database*

# DDAS Accident Report

<b>Report date:</b> 19/05/2006	<b>Accident number:</b> 309
<b>Accident time:</b> 10:45	<b>Accident Date:</b> 13/09/2000
<b>Where it occurred:</b> Nr Haji Mamand village, Barzinja Sharbazher district, Suleimaniyah Governorate	<b>Country:</b> Iraq
<b>Primary cause:</b> Other (?)	<b>Secondary cause:</b> Management/control inadequacy (?)
<b>Class:</b> Excavation accident	<b>Date of main report:</b> 20/09/2000
<b>ID original source:</b> JW/JDG/BK	<b>Name of source:</b> UN/JJ/ELS
<b>Organisation:</b> Name removed	
<b>Mine/device:</b> Type 72 AP blast	<b>Ground condition:</b> rocks/stones route (verge)
<b>Date record created:</b> 19/02/2004	<b>Date last modified:</b> 19/02/2004
<b>No of victims:</b> 3	<b>No of documents:</b> 2

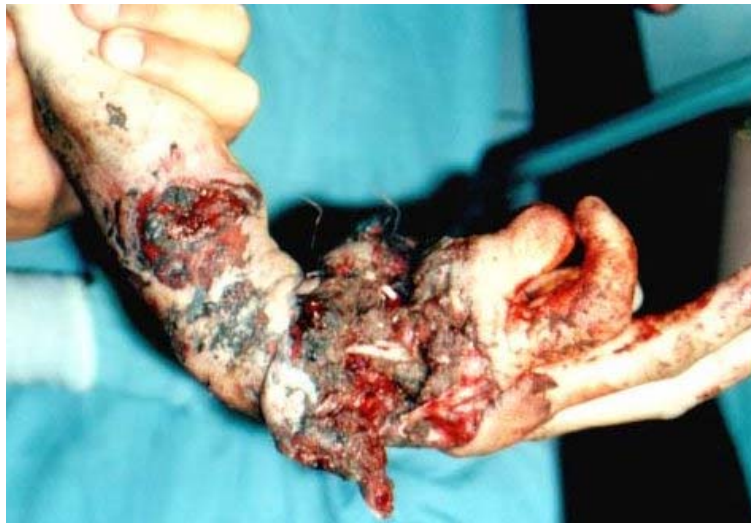
Victim No.1 suffered “facial burn/blast injuries (superficial) as well as fragment (Plastic) to his right eye socket which was removed by the eye doctor who treated him. The piece of plastic was probably from the Type-72 mine: Left hand thumb amputated/severed completely, index finger injured and amputated/ severed partially, middle finger second bone broken and injured badly, lacerations on back of hand and multiple cuts on inside (Palm).”

The picture of the victim's hand reproduced below was sourced elsewhere.

45. There were blast/black burn marks, coming from a typical explosive detonation, to the gloves as well as to the injured hand of [Victim No.1], indicating that his hand must have been

in very close proximity, if not in direct contact with the exploding mine. The markings observed on the piece of the trowel that was found indicate the typical explosion ricochet-burn markings as well as "melt/spotweld" markings. These confirm that the trowel was in very close proximity, if not in direct contact with the explosion for such high heat generating to cause the "melting/spotweld markings".
