# DDASaccident313

# DDAS Accident Report

<b>Report date:</b> 19/05/2006	<b>Accident number:</b> 313
<b>Accident time:</b> 10:20	<b>Accident Date:</b> 07/07/2000
<b>Where it occurred:</b> Lurio River Bridge, (Cabo Delgado)	<b>Country:</b> Mozambique
<b>Primary cause:</b> Field control inadequacy (?)	<b>Secondary cause:</b> Inadequate equipment (?)
<b>Class:</b> Excavation accident	<b>Date of main report:</b> 08/07/2000
<b>ID original source:</b> GZ/AVS2001:MZ02	<b>Name of source:</b> HT (field): IND 133
<b>Organisation:</b> Name removed	
<b>Mine/device:</b> PMN AP blast	<b>Ground condition:</b> bridge and surrounds metal scrap route (verge) trees
<b>Date record created:</b> 20/02/2004	<b>Date last modified:</b> 29/02/2004
<b>No of victims:</b> 1	<b>No of documents:</b> 1

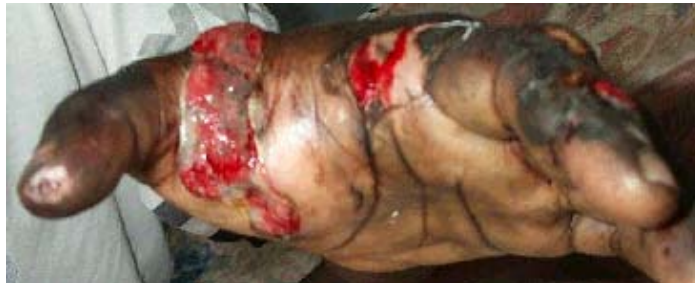
Injuries to the deminer's lower face were caused by the pieces of visor which he had been wearing in the correct manner. The injuries to his left hand were caused by the shattered wooden handle of his enxada which he was using to excavate with. A small point of contention is that the original accident report stated that the casualty had sustained injuries to his right hand rather than those actually to his left. Minor cuts and grazing to his left ankle and upper right arm were caused by secondary fragmentation (soil and stones) from the blast effect of the mine.

The photograph of the victim's hand shown above was made available.

The victim suffered minor cuts and abrasions to the face and damage to his hand, leg and arm.

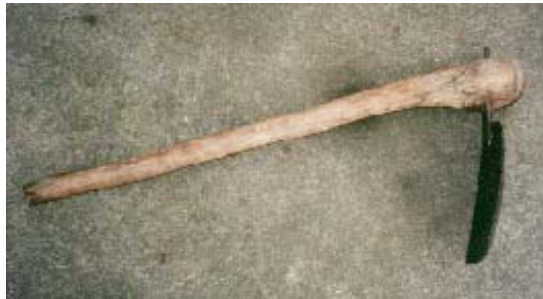
The detector in use was not suitable for use in mineralised soil (as recognized by the decision to use ground-compensating detectors in the internal report) and the quality of the enxada was poor because it broke up in the accident.

A photograph of an enxada is shown above. Locally made, the quality of steel and handle is very variable.

While the use of the tool may be accepted, the quality of the tool being used was clearly inadequate. Hardened steels will crack and shatter in a blast, which appears to have happened in this case. If the blade and the handle were made as one using a medium grade of steel, the tool would be far less likely to shatter and cause injuries – as it apparently did in this case.
