DDASaccident314

Humanitarian Demining Accident and Incident Database
AID

DDAS Accident Report

Report date: 19/05/2006	Accident number: 314
Accident time: 13:00	Accident Date: 07/06/2000
Where it occurred: Power lines North of Rio Ligonha, Nampula Province	Country: Mozambique
Primary cause: Unavoidable (?)	Secondary cause: Inadequate equipment (?)
Class: Excavation accident	Date of main report: 09/06/2000
ID original source: GZ/AVS2001:MZ03	Name of source: HT (field): IND 132
Organisation: Name removed	
Mine/device: M969 AP blast	Ground condition: hard metal fragments pylons and surrounds
Date record created: 20/02/2004	Date last modified: 29/02/2004
No of victims: 1	No of documents: 1

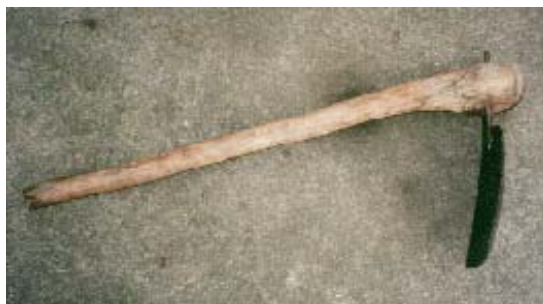
The deminer was obliged to use a full excavation method in hard ground using an enxada.

The use of some kind of pick-axe or hoe is not unusual when conducting area-excavation. The tool is swung in at a low angle and used to shave the face of the excavation in a slow advance. This is the second of three accidents involving this demining NGO and an enxada in Mozambique. See the accidents on 14th April 1998 and on 7th July 2000.

A photograph of an enxada is shown above.
