# DDASaccident315

# DDAS Accident Report

<b>Report date:</b> 15/03/2004	<b>Accident number:</b> 315
<b>Accident time:</b> 10:45	<b>Accident Date:</b> 24/12/1999
<b>Where it occurred:</b> Tower 88, Moamba District, Maputo Province	<b>Country:</b> Mozambique
<b>Primary cause:</b> Victim inattention (?)	<b>Secondary cause:</b> Inadequate equipment (?)
<b>Class:</b> Vegetation removal accident	<b>Date of main report:</b> 29/12/1999
<b>ID original source:</b> MT/AR	<b>Name of source:</b> CND/IND/MT
<b>Organisation:</b> Name removed	
<b>Mine/device:</b> PMN AP blast	<b>Ground condition:</b> bushes/scrub grass/grazing area pylons and surrounds sparse trees wet
<b>Date record created:</b> 20/02/2004	<b>Date last modified:</b> 20/02/2004
<b>No of victims:</b> 1	<b>No of documents:</b> 1

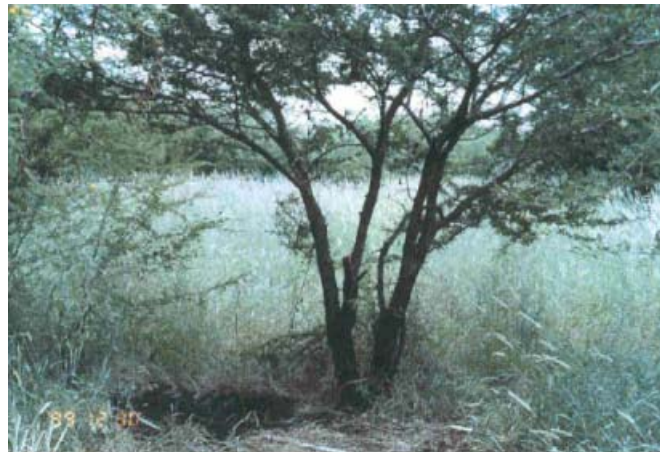
The deminer was injured in an area considered to be densely mined during an attempt to enlarge the cleared area from 20 square metres to 40 square metres. While trying to cut some shrubs he made a "false move" and activated a mine outside his lane with his left foot. The mine was outside the "ring" and below a tree.

A photograph of the accident site is shown above.

The accident was unavoidable due to the squatting posture of the victim when he was working, which did not give him much room for movement. The one movement he made to make more room for work resulted in the accident.

The most serious injuries caused by the mine were mainly due to the demining group not providing their deminers with protective vests.

Pressure put on the deminers to finish the lane in "record time" and "obliging" them to work as volunteers are one of the factors which contributed to the accident.

The demining group must put in place measures which guarantee the safety of deminers. In this regard they have to introduce the mandatory use of protective vests.

From now on, the demining group must acquire an ambulance and not use alternative vehicles, as was the case in this instance.
