DDASaccident318

DDAS Accident Report

Report date: 19/05/2006	Accident number: 318
Accident time: 06:55	Accident Date: 03/04/2000
Where it occurred: Vila Franco do Save, Govuro District, Inhambane Province	Country: Mozambique
Primary cause: Field control inadequacy (?)	Secondary cause: Victim inattention (?)
Class: Excavation accident (Survey)	Date of main report: 05/04/2000
ID original source: IND 2143/ADP-13/DG	Name of source: ADP/IND
Organisation: Name removed	
Mine/device: PMN AP blast	Ground condition: hard rocks/stones
Date record created: 20/02/2004	Date last modified: 20/02/2004
No of victims: 1	No of documents: 2

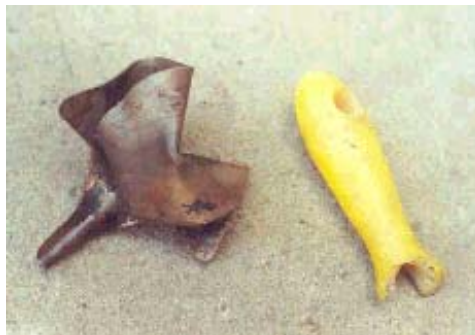
It was later discovered that the entire metal head of the victim's trowel was inside his thigh. This was not discovered until he was in hospital. The distorted trowel head and separated handle is shown below.

From the position of the shovel and the handle of the shovel [trowel] the investigators concluded that he had struck the mine on the left side.

The time between hearing the detector signal and the detonation was very short, meaning that the victim failed to use his prodder to "soften" the ground before using the trowel.

The use of handtools must be better “supervised and carried through by Section Commanders”.

The Field Commanders’ guide should be updated to avoid further accidents arising through the misuse of demining tools. Pinpointing detector readings and marking the centre clearly will support these efforts.

Partly as a result of this accident, the demining group decided to use purpose designed, blast-resistant handtools in future.
