## DDASaccident322

# DDAS Accident Report

<b>Report date:</b> 15/03/2004	<b>Accident number:</b> 322
<b>Accident time:</b> 10:55	<b>Accident Date:</b> 10/07/2001
<b>Where it occurred:</b> Rasa Koshare minefield No.315	<b>Country:</b> Kosovo
<b>Primary cause:</b> Field control inadequacy (?)	<b>Secondary cause:</b> Inadequate training (?)
<b>Class:</b> Vegetation removal accident	<b>Date of main report:</b> 24/07/2001
<b>ID original source:</b> TG/CC/JF No 007/2001	<b>Name of source:</b> KMACC
<b>Organisation:</b> Name removed	
<b>Mine/device:</b> PMA-3 AP blast	<b>Ground condition:</b> electromagnetic leaf litter woodland
<b>Date record created:</b> 20/02/2004	<b>Date last modified:</b> 10/03/2004
<b>No of victims:</b> 2	<b>No of documents:</b> 1

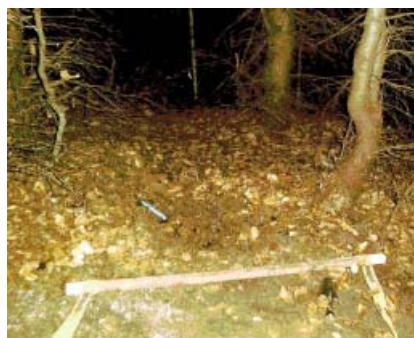
[The picture above shows the accident site. The victim's secateurs are lying beside the blast crate in front of (and central to) the base-stick. Beyond the secateurs to the right, there are fresh cuts on a small tree.]

Victim No.1 has stated that he tripped over the base stick and then stepped on the mine. However upon investigation of the blast hole and surrounding area it was discovered that the branches of the tree to the left of the lane had been cut back. This cutting of the branches was well past the 30cm clearance in front of the base stick, which is a breach of demining group's approved SOPs. These branches had been cut by someone leaning forward over the base stick with the cutters, and cutting the branches back. The distance from the base stick to the cut branches was in some cases over one meter.

The deminer [Victim No.1] has stated that he tripped on his base stick and then stepped on the PMA-3 mine. The evidence at the accident site clearly shows that he was leaning forward and cutting branches outside the 30cm clearance limit in front of his base stick. In doing this he lost his balance and then stepped on the mine.
