DDASaccident323

DDAS Accident Report

Report date: 15/03/2004	Accident number: 323
Accident time: 12:50	Accident Date: 30/05/2001
Where it occurred: Rasa Koshare minefield No.358	Country: Kosovo
Primary cause: Field control inadequacy (?)	Secondary cause: Inadequate training (?)
Class: Missed-mine accident (survey)	Date of main report: 11/06/2001
ID original source: TG/CC/JF No 006/2001	Name of source: KMACC
Organisation: Name removed	
Mine/device: PMA-3 AP blast	Ground condition: bushes/scrub electromagnetic woodland
Date record created: 20/02/2004	Date last modified: 21/02/2004
No of victims: 1	No of documents: 2

The accident occurred at one of the Rasa Koshare minefield's, Task Dossier Number W02-37, minefield number 358, GR 34T DN 3503 0246 on 30 May 2001 at 12:50.

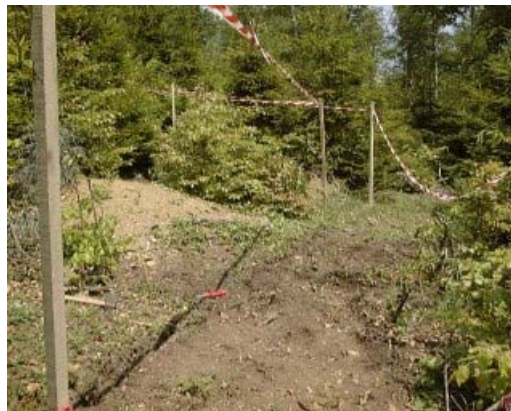
According to the marking that was in place at the time of the accident this mine was just on the outside of the cleared area. There was mine marking tape fixed to the top of the danger sticks, however there was not any marking tape at the bottom of the sticks in the vicinity of the mine. The victim's foot must have only caught the very outside edge of the mine. The resultant blast caused injuries to the victim's face, chest, right arm and right foot.

As a consequence of the explosion the hammer was forced into the victim's chest causing bruising, and he then dropped the hammer [the photograph below shows a small hand axe, not a hammer: the red handled knife marks the crater].

The hammer has then fallen outside the marked area. The International Supervisor was standing approximately 2 metres from the victim, and facing in the opposite direction. The International Supervisor did not see the actual explosion or receive any injuries from the blast. Immediately after the explosion he moved to assist the victim and calm him. As the International Supervisor did not realise the victim had received injuries to his foot he attempted to guide him out of the lane and onto the road approximately 35 metres away. The victim was unable to walk and therefore the International Supervisor called to the SL to bring a stretcher to his site. The International Supervisor then called the demining NGO base and reported the accident and requested a helicopter casevac. When the SL arrived both he and the International Supervisor carried the victim out to the road on the stretcher where the medical team was waiting to provide first aid.

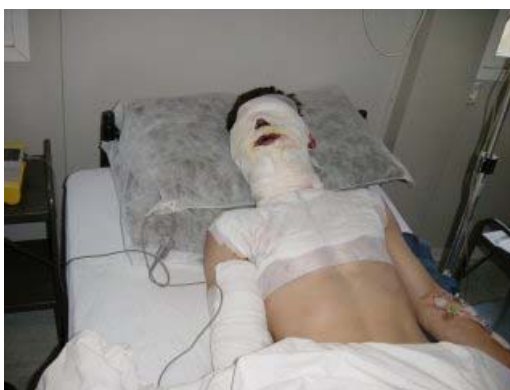
The victim was stabilised and from there he was then taken by ambulance to the HLS located approximately 1.5 km to the south. Further treatment was provided at the HLS whilst awaiting the arrival of the casevac helicopter. The helicopter arrived at 13:47 which was 50 minutes after the request for the helicopter was made and almost 60 minutes after the accident. The photograph below shows the victim in hospital on the day after the accident. The victim was conscious and able to talk whilst awaiting the arrival of the helicopter.
