DDASaccident324

DDAS Accident Report

Report date: 15/03/2004	Accident number: 324
Accident time: 11:05	Accident Date: 26/04/2001
Where it occurred: Nr Kraljan, MNB West	Country: Kosovo
Primary cause: Field control inadequacy (?)	Secondary cause: Management/control inadequacy (?)
Class: Missed-mine accident	Date of main report: 03/05/2001
ID original source: MF/CC/JF No.002/2001	Name of source: KMACC
Organisation: Name removed	
Mine/device: PMA-3 AP blast	Ground condition: leaf litter soft woodland (light)
Date record created: 20/02/2004	Date last modified: 20/02/2004
No of victims: 1	No of documents: 3

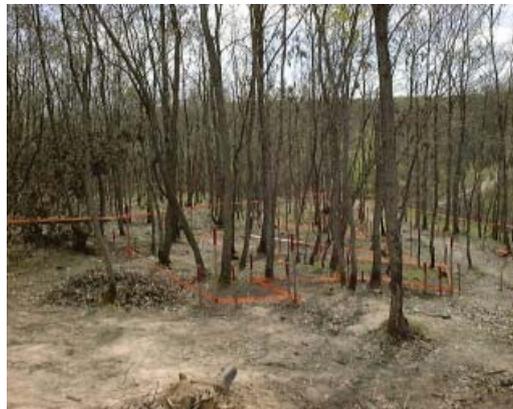
[The accident site. The area up to the trees had been flailed.]

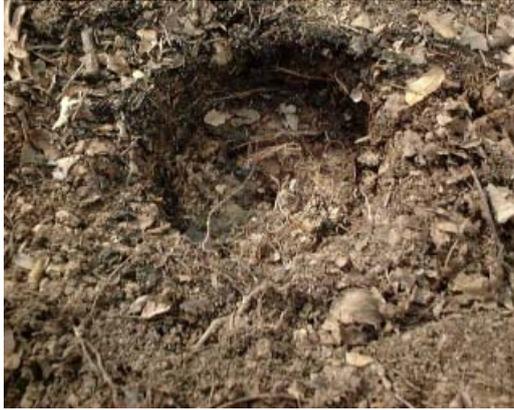
6. Following the uncontrolled detonation, all operations were stopped, the Site Supervisor secured the site and cleared up to, and then recovered the mine. The mine was located 55cm forward of the original EDD box marking. All relevant accident information was then passed up through the chain of command to the MACC.

[The hole left by the mine after removal. (Hole 110mm in diameter and 40mm deep).]

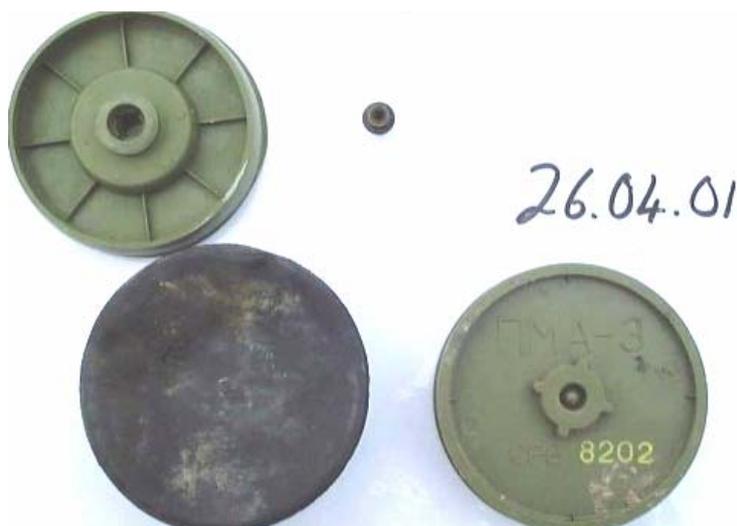
- There was an explosion as opposed to a detonation of the PMA-3 anti-personnel mine when [the demining group] deminer stood on it. The low explosive chemical igniter exploded, but the “flash” was not transferred to the high explosive detonator. Explosions occur in low explosive compounds, whereas a detonation occurs in high explosive compounds.

- Visual inspection of the UPMA-3 fuze showed that the chemical igniter had functioned, but the detonator was still in place. Should the detonator have functioned and the detonating wave been transferred into the main secondary high explosive fill then the resulting injuries to the deminer would have been very serious.

The mine casing was not damaged, and even the brittle plastic of the UPMAH fuze was not broken – as shown in the picture below.
