# DDASaccident324

# DDAS Accident Report

<b>Report date:</b> 15/03/2004	<b>Accident number:</b> 324
<b>Accident time:</b> 11:05	<b>Accident Date:</b> 26/04/2001
<b>Where it occurred:</b> Nr Kraljan, MNB West	<b>Country:</b> Kosovo
<b>Primary cause:</b> Field control inadequacy (?)	<b>Secondary cause:</b> Management/control inadequacy (?)
<b>Class:</b> Missed-mine accident	<b>Date of main report:</b> 03/05/2001
<b>ID original source:</b> MF/CC/JF No.002/2001	<b>Name of source:</b> KMACC
<b>Organisation:</b> Name removed	
<b>Mine/device:</b> PMA-3 AP blast	<b>Ground condition:</b> leaf litter soft woodland (light)
<b>Date record created:</b> 20/02/2004	<b>Date last modified:</b> 20/02/2004
<b>No of victims:</b> 1	<b>No of documents:</b> 3

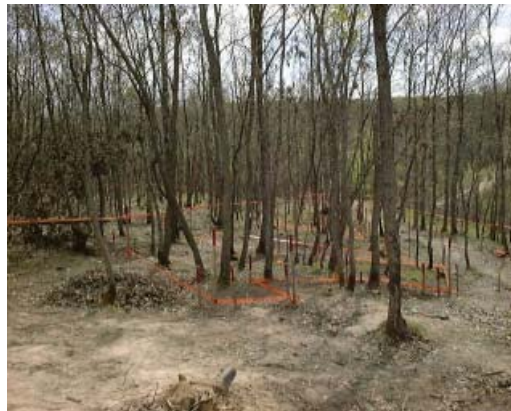
[The accident site. The area up to the trees had been flailed.]

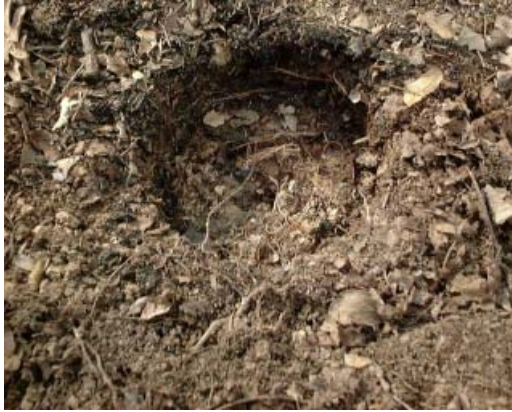
6. Following the uncontrolled detonation, all operations were stopped, the Site Supervisor secured the site and cleared up to, and then recovered the mine. The mine was located 55cm forward of the original EDD box marking. All relevant accident information was then passed up through the chain of command to the MACC.

[The hole left by the mine after removal. (Hole 110mm in diameter and 40mm deep).]

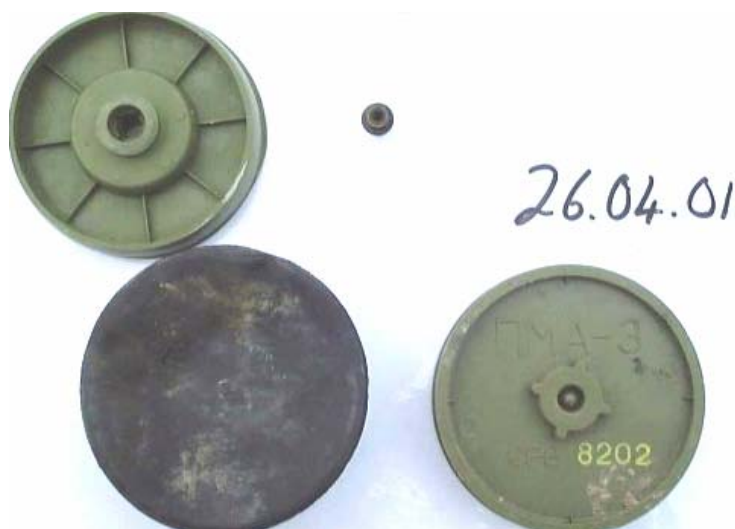
- There was an explosion as opposed to a detonation of the PMA-3 anti-personnel mine when [the demining group] deminer stood on it. The low explosive chemical igniter exploded, but the “flash” was not transferred to the high explosive detonator. Explosions occur in low explosive compounds, whereas a detonation occurs in high explosive compounds.

- Visual inspection of the UPMA-3 fuze showed that the chemical igniter had functioned, but the detonator was still in place. Should the detonator have functioned and the detonating wave been transferred into the main secondary high explosive fill then the resulting injuries to the deminer would have been very serious.

The mine casing was not damaged, and even the brittle plastic of the UPMAH fuze was not broken – as shown in the picture below.
