# DDASaccident326

# DDAS Accident Report

<b>Report date:</b> 15/03/2004	<b>Accident number:</b> 326
<b>Accident time:</b> 11:20	<b>Accident Date:</b> 22/05/2001
<b>Where it occurred:</b> Rasa Koshare, Kosovo/Albania border	<b>Country:</b> Kosovo
<b>Primary cause:</b> Field control inadequacy (?)	<b>Secondary cause:</b> Field control inadequacy (?)
<b>Class:</b> Missed-mine accident	<b>Date of main report:</b> 29/05/2001
<b>ID original source:</b> TG/CC/JF No 005/2001	<b>Name of source:</b> KMACC
<b>Organisation:</b> Name removed	
<b>Mine/device:</b> PMA-3 AP blast	<b>Ground condition:</b> leaf litter rocks/stones soft woodland
<b>Date record created:</b> 20/02/2004	<b>Date last modified:</b> 20/02/2004
<b>No of victims:</b> 1	<b>No of documents:</b> 2

4. The accident occurred at one of the Rasa Koshare minefield's, Task Dossier Number W02-37, minefield number 315, GR 34T DN 3509 0156 on 22 May 2001 at 1120 hours.

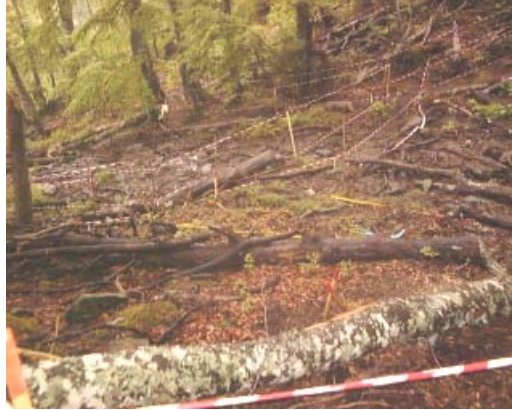
### **View of accident lane**

Lane indicating tape in accordance with present [demining group] operating procedure. There is potential for this tape to be moved into uncleared ground, thereby creating a situation for someone to inadvertently step into this uncleared area.

- There were no witnesses to the accident.
- The clearance lane that [the victim] was working in was approximately 4m long, however according to [the demining group] SOPs there are no clearance lane sticks put in place until a 5m lane has been cleared. This means that the lane indicating tape is not secured except by the start of lane pegs and the base stick. Although it was not a factor in this particular situation, this leaves the tape free to possible movement either side of the actual cleared ground. This has the potential for someone to inadvertently step into an uncleared area.

- [The demining group] amend their SOPs to include the placing of clearance lane sticks (approximately 30 – 50cm in length) every meter when deminers are conducting clearance. This will clearly define the edge of the cleared lane as they progress toward the 5m mark where they then place the longer danger sticks and tape.

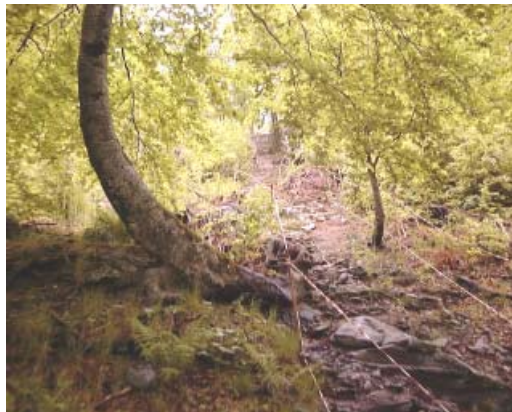
View of steep access to the accident site from the road, also the site of the previous [other demining group] accident.
