DDASaccident327

Humanitarian Demining Accident and Incident Database
AID

DDAS Accident Report

Report date: 15/03/2004	Accident number: 327
Accident time: 10:43	Accident Date: 18/09/2000
Where it occurred: Morina village, MNB West, VJ MF 3501	Country: Kosovo
Primary cause: Field control inadequacy (?)	Secondary cause: Inadequate training (?)
Class: Excavation accident	Date of main report: 18/04/2001
ID original source: MD/EW/LH/JF	Name of source: KMACC
Organisation: Name removed	
Mine/device: PMA-2 AP blast	Ground condition: bushes/scrub grass/grazing area
Date record created: 20/02/2004	Date last modified: 20/02/2004
No of victims: 1	No of documents: 3

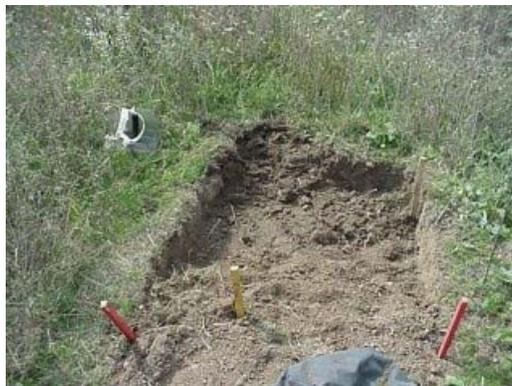
The picture above shows the visor and blast "crater".

There is dust/debris blown into the inside of the visor. Pitting/dust is present towards the base of the visor on the inside. Indicating either the visor has been worn incorrectly, the deminer was almost over the top of the mine when it detonated or the deminer was looking up and away from the mine when it detonated. The first of these options is the most likely, possibly combined with the third.

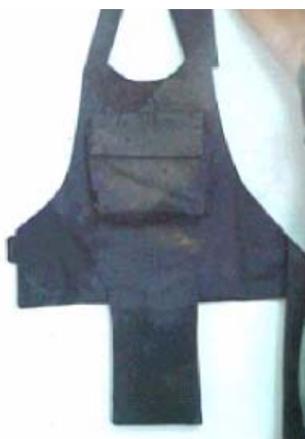
16. At the time of the accident [the Victim] was wearing the proper uniform and personnel protective equipment (PPE) according to the [Demining group] SOPs. However the facial and eyes injuries indicate that the visor was worn incorrectly and that the deminer was almost over the top of the mine when it detonated. According to the [Demining group] the full-face visor they use is designed to withstand the effects of blast and fragmentation mine at close range. The Body Armour used by [Demining group] is a lightweight, one piece, protective vest that is designed to withstand the effects of low velocity ballistic fragmentation at very close ranges. Even if the equipment is worn properly there is always a small gap between the Body Armour and the bottom part of the visor.

[Pictures of the victim are in the Medical report. The picture above shows the Victim's minimal frontal body protection with no collar to interface with the visor.]

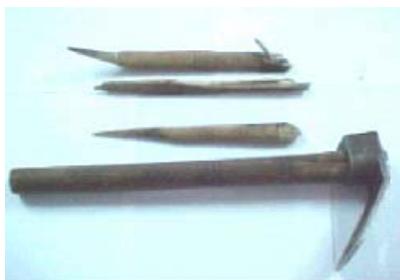
17. The equipment used by [the Victim] at the time of the accident was the appropriate equipment issued by [Demining group] for the sapping drill [metal-detectors were apparently not in use.]. The metal front part of the sapping tool has not been found yet.

The picture above shows the recovered parts of the sapping tool (shards of wood) and a complete tool showing the missing metal head.

Initial impression at the site and from the injuries suffered and damage to equipment, is that the deminer was working in a half-kneeling position excavating with his hand tool in a scraping motion across the face of the lane. The hand tool disintegrated and pieces of the handle have been recovered. The metal head of the tool has not been located at this time.

[Demining group] management must review their SOPs and re-write the chapter 8 "Conducting of Clearance" and conduct refresher training.

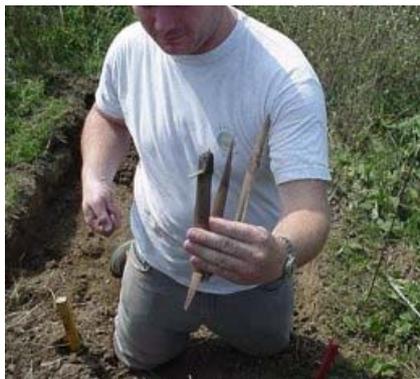
[The picture above was taken during the investigation and shows one of the individuals (the picture is cropped for anonymity) at the accident site with parts of the victim's hoe-handle in his hand. The investigator is on his knees at the end of the lane alongside a marker for a previously located mine. He is not wearing body-armour or visor.]

A final failing of field management was the fact that the initial investigation was conducted with the senior staff involved inspecting the point of initiation while wearing no protective equipment at all. The fact that they photographed this and included it in their report implies that they were not aware that they should have been wearing the PPE.

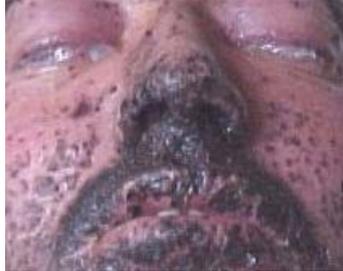
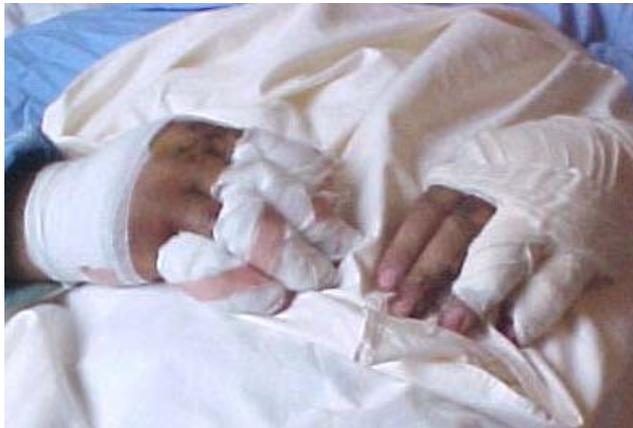
A left shoulder injury was noted by the Section Commander who rescued the Victim from the minefield – see Statements. The Victim's face and hands were photographed in hospital. [It is hard to understand why possible eye injury was not noted on the site.]

The casualty suffered the following injuries Injuries to both eyes (Extent unknown at this time). A deep penetration to the right hand between the thumb and first finger although no damage to the bone, minor cuts and burns to the left hand particularly down the fourth finger. Cuts and minor burns to area between knees and thighs on both legs. Minor abrasions and burns to the face.
