## DDASaccident328

# DDAS Accident Report

<b>Report date:</b> 15/03/2004	<b>Accident number:</b> 328
<b>Accident time:</b> 09:15	<b>Accident Date:</b> 31/10/2000
<b>Where it occurred:</b> Nr Jasiq village, MNB West	<b>Country:</b> Kosovo
<b>Primary cause:</b> Field control inadequacy (?)	<b>Secondary cause:</b> Unavoidable (?)
<b>Class:</b> Missed-mine accident	<b>Date of main report:</b> 07/11/2001
<b>ID original source:</b> MD/CC/JF	<b>Name of source:</b> KMACC
<b>Organisation:</b> Name removed	
<b>Mine/device:</b> PMA-2 AP blast	<b>Ground condition:</b> grass/grazing area rocks/stones sparse trees
<b>Date record created:</b> 20/02/2004	<b>Date last modified:</b> 20/02/2004
<b>No of victims:</b> 1	<b>No of documents:</b> 3

The following is the Accident report made by the Kosovo MACC, edited for anonymity. Excess pictures have also been removed.

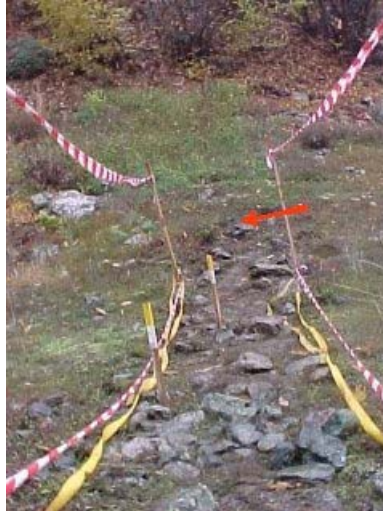
The photograph above shows the clearance lane where the accident occurred.

[The red arrow indicates the rock beyond which the blast occurred: notice how far ahead of the lane marking it is. See paragraph 19 in which the investigator reports that the base stick was 4 metres ahead of the marking. The investigator wrote that he was standing on a rock in a “cleared area”, but there is no obvious excavation leading to the site so it seems that he was actually standing in an uncleared area trying to locate the next mine by eye. The next mine was visible – a photograph of its pressure-star was included in the report.]

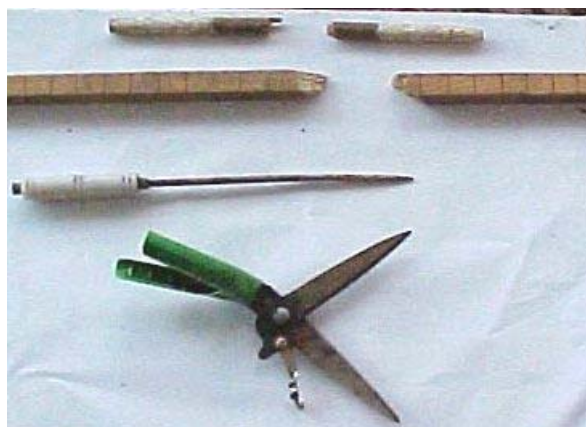
19. [The Victim] was not using any equipment at the time of the accident. However he was carrying a small pair of vegetation cutters in his right hand. Both the vegetation cutters and the two parts of the broken base stick were located in front of the blast hole in the uncleared area. The base stick [shown below] is broken in two and was approximately 4 meters inside the uncleared area.
