DDASaccident330

DDAS Accident Report

Report date: 15/03/2004	Accident number: 330
Accident time: 11:40	Accident Date: 18/11/2000
Where it occurred: MNB West, Dakovica, Koshare West	Country: Kosovo
Primary cause: Management/control inadequacy (?)	Secondary cause: Inadequate equipment (?)
Class: Handling accident	Date of main report: 22/11/2000
ID original source: MD/CC/JF	Name of source: KMACC
Organisation: Name removed	
Mine/device: PMA-3 AP blast	Ground condition: rocks/stones woodland (light)
Date record created: 20/02/2004	Date last modified: 20/02/2004
No of victims: 1	No of documents: 3

Minefield Accident - 18 November 2000

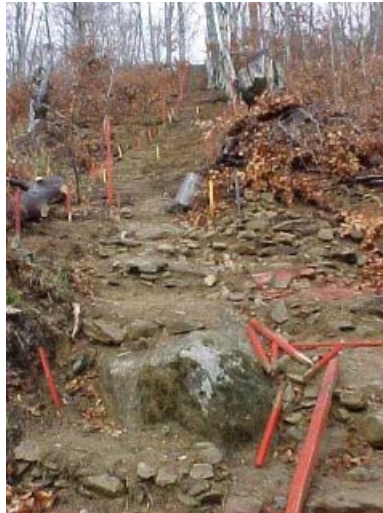
[The picture above shows the accident site. the visor was the victim's. It is some metres from the "adjacent stream".]

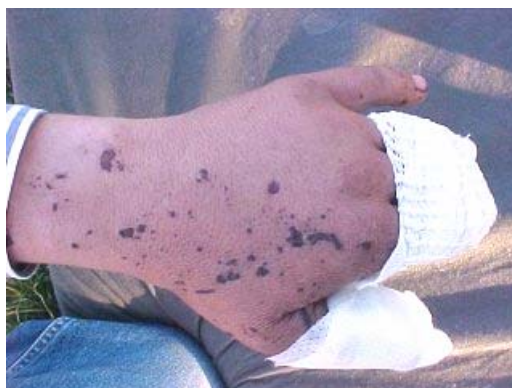
18. At approximately 12h40, the helicopter landed at the HLS. The casualty was loaded and flew directly to the Italian KFOR field hospital. The casualty arrived at the Italian KFOR field hospital at 12h50. The Doctor on duty immediately assessed him. No surgical procedures were required and he was kept for observation overnight and released the next day (see pictures of injuries).

“Right hand - blast injuries, cuts and fragmentation from mine and dirt below skin.

Left hand - similar but less serious than right hand.

Left leg - small burn below knee.

Right leg - minor injuries below knee”.

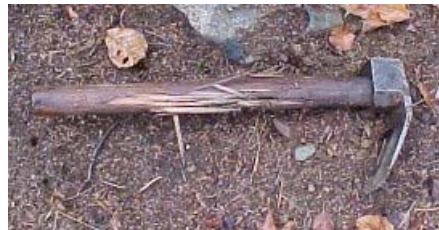
4. The information provided by the [Demining group] to the MACC in the "Incident Report" is confirmed. However the BOI does not concur with some of the [Demining group]'s findings regarding the contributory factors to this accident. A copy of the "Incident Report" is attached as Annex C [see Related papers]. The accident occurred at approximately 11h40 on November 18th, 2000 in a minefield located near the village of Koshare GR DN 3511 0148. Mr. [the Victim] was in a squatting or kneeling position in front of his one-meter wide lane using his sapping tool to pull vegetation and incidentally activated a PMA-3 blast mine. The casualty suffered very minor blast trauma to both hands and lower parts of his legs. He was released from the Italian KFOR field hospital the next day. There were no other personnel injured in the accident or any witness and the property damage was only to the sapping tool.

Mine blast damage on the handle of the sapping tool. [What the demining group call a "Trowel" is shown below.]

The secondary cause is listed as "*Inadequate equipment*" because the tool used by the demining group was inappropriate. Euphemistically described as a "trowel" by this group around the world, the tool is a hoe or a side-headed axe. Its wooden handle has frequently featured in injuries for this group.

The centre of the wooden shaft had black/grey scorch marks and was broken at the centre although, not completely severed.

Deminers have only been taught to use the trowel for excavating the ground in a shaving motion working from side to side and not downwards. The trowel should not be used to scrape the surface of the ground or pull vegetation especially as trip wires have been found in the area and some PMA-2 AP mines, which have been found in other areas of Koshare, have a plunger which usually stands above the surface. [The Victim] had been warned by the Team Leader about his work on a number of occasions and this was only his second day in this difficult minefield. Although the minefields he had worked in prior to Koshare had been mixed AP/AT, they had been mapped accurately (Serb records) and as well as being able to pretty much guarantee where the mines were laid, the terrain was far less challenging. Koshare is punishing and there is no room for errors and therefore speed of clearance has to be balanced with cautiousness. He was working carelessly and unsafe and has been extremely lucky to escape with only minor injuries.

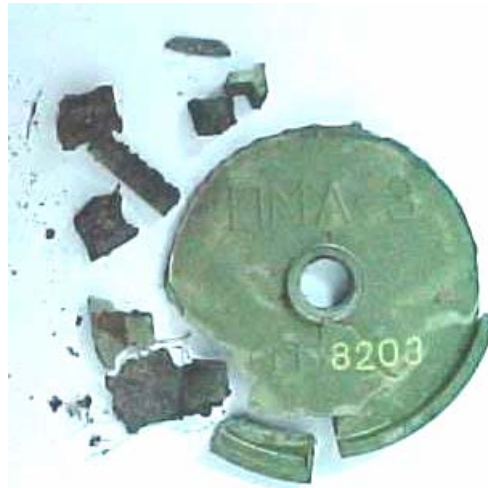
22. The mine was a PMA-3 anti-personnel blast mine. The evidence at the accident site confirms that the mine was surface laid and up side down.

Large parts of the mine's plastic case were recovered and are pictured below. The presence of most of the base implies that it was in the ground and so the mine was not upside-down (as the internal investigator speculated – see Related papers).
