DDASaccident340

Humanitarian Demining Accident and Incident Database
AID

DDAS Accident Report

Report date: 19/05/2006	Accident number: 340
Accident time: 10:15	Accident Date: 09/11/2000
Where it occurred: Nr. Zavala Village, Ravno Municipality	Country: Bosnia Herzegovina
Primary cause: Field control inadequacy (?)	Secondary cause: Inadequate equipment (?)
Class: Vegetation removal accident	Date of main report: 22/11/2000
ID original source: AS/AS/PS/SD	Name of source: BiH MAC
Organisation: Name removed	
Mine/device: PROM-1 AP Bfrag	Ground condition: agricultural (abandoned) bushes/scrub grass/grazing area metal fragments rocks/stones trees
Date record created: 21/02/2004	Date last modified: 21/02/2004
No of victims: 1	No of documents: 1

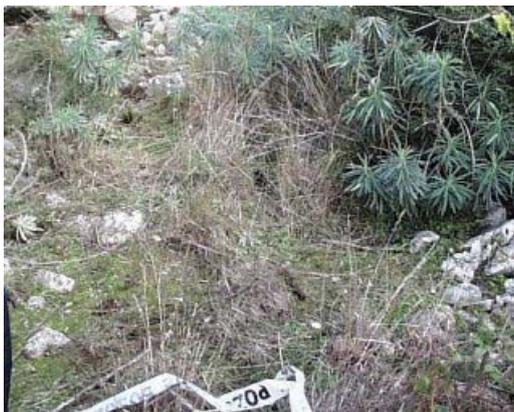
The flat part of the field is suitable for both agriculture and growing grass. Due to long period of its being non-inhabited, grass and thin trees grown over it. There is about 50% of the task where the mild meadow turns to steep rocky area where there is lot less grass and much more thick bushes of even 2-3 metres height. There is a small track leading from the west side of the task, from the railroad track and between the rocky areas. Due to some soil layers on it, this track is grown in grass between the bushes. Due to drought usual during the year, the thick bushes and grass were dry, while new grass grew after a few autumn rains.

[The picture above shows the accident site.]

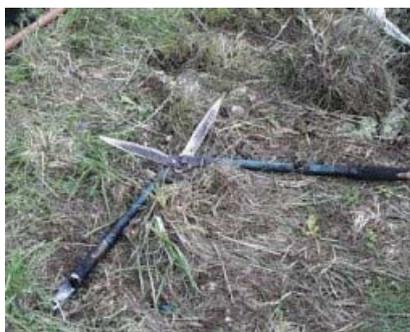
[The picture above shows the long-handled shears in use. Their long handles invite the user to cut beyond the area checked.]

Garden shears were used for cutting vegetation in the working lane in front of the base stick (bushes and grass that grew very thick near the track leading to the field, and new grass is visible through the rests of the dried bushes). Based on the status at the site of the accident, there are two possibilities of making a mistake in the basic working procedure, and those are:

The tools for controlled removal of vegetation were not suitable (instead of smaller shears for cutting grass, garden shears were used for both bushes and grass. The fact is that when cutting bushes we can easily see the level of the ground while conducting removal.

2. The vegetation cutting tools used in the working lane in front of the base stick should be adapted to the vegetation, cutting with control, in order to locate even a surface laid mine, protruding fuse or an UXO.
