# DDASaccident341

Humanitarian Demining Accident and Incident Database  
*AID*

# DDAS Accident Report

<b>Report date:</b> 17/03/2004	<b>Accident number:</b> 341
<b>Accident time:</b> 08:30	<b>Accident Date:</b> 29/08/2000
<b>Where it occurred:</b> Jahorina, Palosevina	<b>Country:</b> Bosnia Herzegovina
<b>Primary cause:</b> Field control inadequacy (?)	<b>Secondary cause:</b> Field control inadequacy (?)
<b>Class:</b> Excavation accident	<b>Date of main report:</b> 01/09/2000
<b>ID original source:</b> AS/AA/BK	<b>Name of source:</b> BiH MAC
<b>Organisation:</b> Name removed	
<b>Mine/device:</b> PMA-3 AP blast	<b>Ground condition:</b> grass/grazing area metal fragments pylons and surrounds rocks/stones
<b>Date record created:</b> 21/02/2004	<b>Date last modified:</b> 17/03/2004
<b>No of victims:</b> 1	<b>No of documents:</b> 2

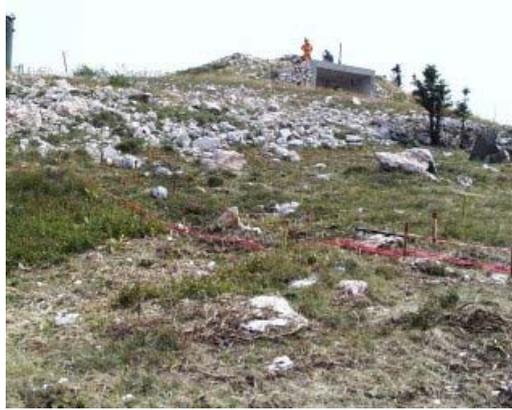
[The accident area is shown above.]

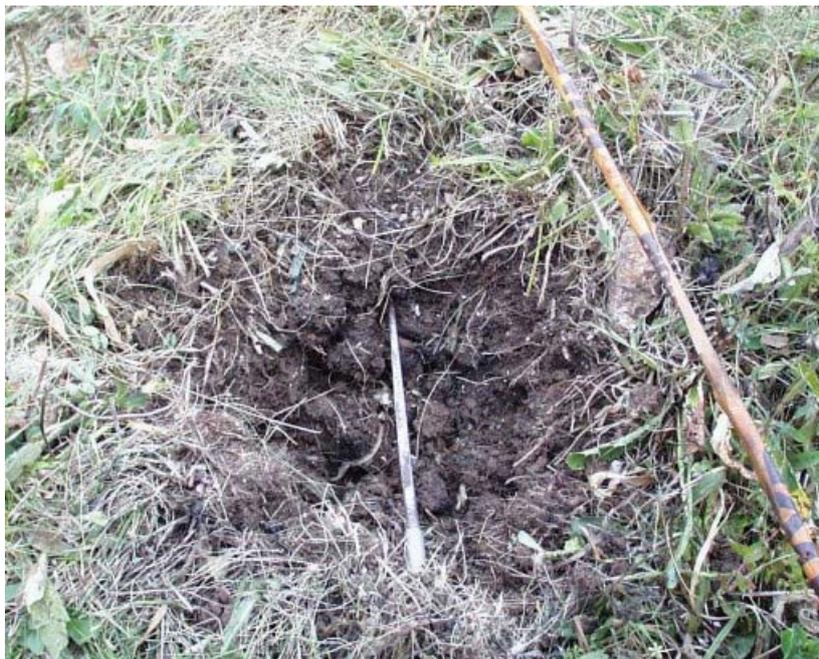
[The Victim's long prod is shown above - in the blast crater.]

The first rock that was moved by [the Victim]. He conducted this move in order to search the location underneath the stone. The previous disturbance of EDDs on that area was confirmed by him activating the mine. The rock that covered the location of the mine involved was probably thrown at that place due to bombing explosion, but had not activated the mine due to its big and flat surface. The rock was removed to approximately 1 m under the crater, at the very edge of the box (photograph 5, Annex E). The traces of its previous position on the ground above the crater of the activated mine are shown in photographs 6 and 9.

The critical mine activated by [the Victim] WAS underneath the big rock thrown on the ground during the bombing. The rock mentioned did not activate the mine due to its large leaning surface.

It is possible to activate a PMA-3 in the hard surface since it is hard to make a difference when touching the rubber part with the prodder. It is what the demining work consists of. In this particular case, it was easier to activate the mine due to the slope of the ground, the position of the mine as well as the length of time it actually was in the ground. This means that it did not require the same force of prodding in comparison to the period of 6 months when it is laid and reliable regarding its activation characteristics.

When using manual methods in areas with rock scattered over, rocks are to be gently removed (taken up or pulled if bigger) to the safe areas, which would totally remove the mine threat regarding the possibility of a mine left under a stone / rock scattered during bombing over mined areas.
