DDASaccident342

DDAS Accident Report

LESSON LEARNED – DEMINING ACCIDENT AUGUST 23rd 2000

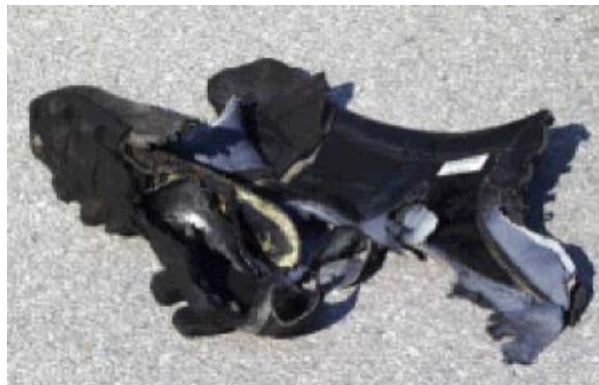
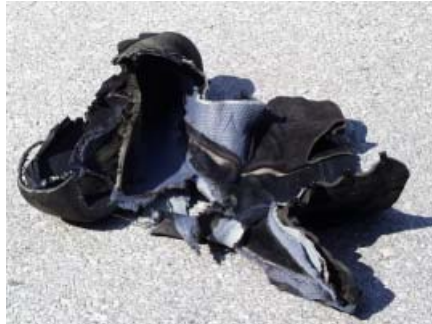
[The Victim's boot is shown above. It is a Welco blast boot designed to be worn with overboots. The overboots were not worn in this instance. These pictures were not included in the original report.]

The use of the Welco blast boot (a donation to the region) did not reduce the Victim's injuries. A MAC representative reported that it could not be worn with the overboot (as designed) because of the uneven terrain. This full boot (with overboot) have been shown to be of some protection when stepping on a mine as small as a PMA-3. However, it has not been shown to be of any value when stepping on the PMA-1 or PMA-2 mines that are also common in the region. Source: US Army Communications - Electronics Command Night Vision Electronic Sensors Directorate, Fort Belvoir, VA 22060-5806 - Final Report of the Lower Extremity Assessment Program (LEAP - 99-2), August 2000 - carried out by the US Army Institute of Surgical Research, Extremity Trauma Study Branch, Fort Sam Houston, TX 78234-6315

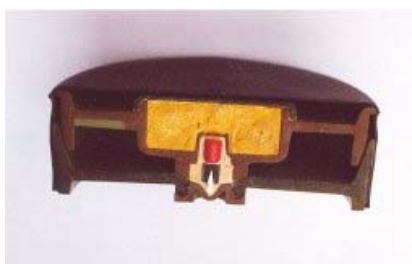
The injuries resulting from stepping on a PMA-3 in ordinary footwear vary from traumatic amputation to minor bruising. The picture below shows why this happens. It shows a cut-away section through a PMA-3. The 35g Tetryl is in the top and centre of the mine. The area of pressure-plate surrounding the HE is actually larger than the area of pressure-plate over it. If a victim is fortunate, they step on the pressure plate but the explosive charge is not beneath their foot.
