# DDASaccident343

# DDAS Accident Report

<b>Report date:</b> 19/05/2006	<b>Accident number:</b> 343
<b>Accident time:</b> 14:45	<b>Accident Date:</b> 17/08/2000
<b>Where it occurred:</b> Sudici region, Rogatica Municipality	<b>Country:</b> Bosnia Herzegovina
<b>Primary cause:</b> Management/control inadequacy (?)	<b>Secondary cause:</b> Inadequate training (?)
<b>Class:</b> Other	<b>Date of main report:</b> 30/08/2000
<b>ID original source:</b> AS/JO/NH/BK	<b>Name of source:</b> BiH MAC
<b>Organisation:</b> Name removed	
<b>Mine/device:</b> PROM-1 AP Bfrag	<b>Ground condition:</b> metal fragments route/path
<b>Date record created:</b> 21/02/2004	<b>Date last modified:</b> 21/02/2004
<b>No of victims:</b> 4	<b>No of documents:</b> 2

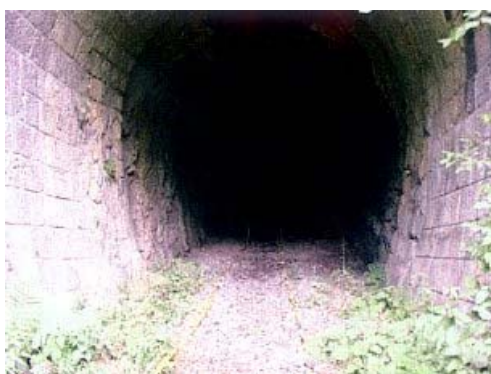
[The picture above shows the tunnel where the accident occurred.]

Explosive device that caused the accident was a PROM-1 mine whose plate was found in the crater made where it detonated, at 25 cm depth from the ground level and 50 cm from the right wall of the tunnel. While investigating the crater on August 23rd 2000 (victims were already taken out), Board of Inquiry requested that Dobož "B" team, who cleared and marked the spot, should clear another working lane by the right side of the tunnel wall in the direction of the crater, which was to be 1.5 metres long towards the crater and another metre further, towards the crater of the mine that killed the fishermen. At about 30 cm from the crater Board of Inquiry found a PMA-2 that was absolutely covered by gravel. The distance of the crater made where the mine detonated is approximately 2.5 metres from the right side, in the direction of tunnel's length. According to Board of Inquiry opinion, the crater of the mine that caused demining accident was right underneath the back of the late fisherman Radomir Lucić, as well as the PMA-2 mine which was found during the investigation.

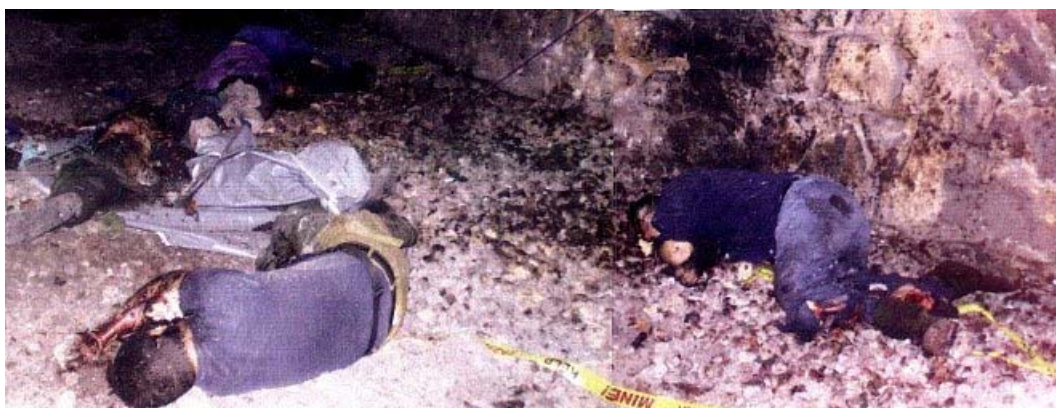
[The picture shows the Victims photographed the next day.]

During the entrance to the cleared part of the mined area and in order to take photographs of the second fisherman and to take further actions on his taking out that actually led to the accident, the killed and the injured wore no personal protective equipment.

Photographs of the accident's victims that prove what is stated above are attached as Annex G. [Not made available, but some photographs were. Other photographs reveal that the PPE being worn while the group recovering bodies approached the accident site was a long visor and a frontal apron.]

The fact that the Victim's corpses were only checked by a deminer for signs of life is the reason why "inadequate medical provision" is listed in the notes. The photographs of the dead (others are in the file) do not show obviously fatal injuries – although there also no indication that the victims had moved after the detonation. However, if it was safe for a deminer to check for signs of life, it should also have been safe for a medic to do so.
