# DDASaccident344

# DDAS Accident Report

<b>Report date:</b> 19/05/2006	<b>Accident number:</b> 344
<b>Accident time:</b> 13:00	<b>Accident Date:</b> 26/06/2000
<b>Where it occurred:</b> Jorgici-Vrela, Teslic municipality, Republic of Srpska	<b>Country:</b> Bosnia Herzegovina
<b>Primary cause:</b> Management/control inadequacy (?)	<b>Secondary cause:</b> Inadequate training (?)
<b>Class:</b> Excavation accident (survey)	<b>Date of main report:</b> 04/07/2000
<b>ID original source:</b> RB/AA/PJ/SP/EB	<b>Name of source:</b> BiH MAC
<b>Organisation:</b> Name removed	
<b>Mine/device:</b> TMM-1 AT blast	<b>Ground condition:</b> ditch/channel/trench metal scrap soft
<b>Date record created:</b> 21/02/2004	<b>Date last modified:</b> 21/02/2004
<b>No of victims:</b> 2	<b>No of documents:</b> 2

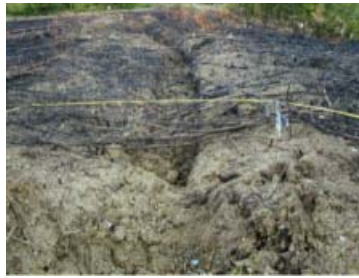
[The picture above shows the trench where the accident occurred – and illustrates how the area was burned off but the undergrowth not cleared away.]

16. Area where accident occurred is metal contaminated with pots, wire, metal tapes, pieces of iron and lots of dispersed burnt vegetation. Final internal control has not conducted its job at this area properly.

57. The area on the very top of the hill (around the accident site) is done quite badly. There is a lot of metal on the surface (metal is to be collected into metal collecting pit), trees in the ruined bunker was not moved, nor in the trenches. Photographs in Annex. What is stated above is not written in the RO Banja Luka inspectors' reports or in the monitors' reports from the site.

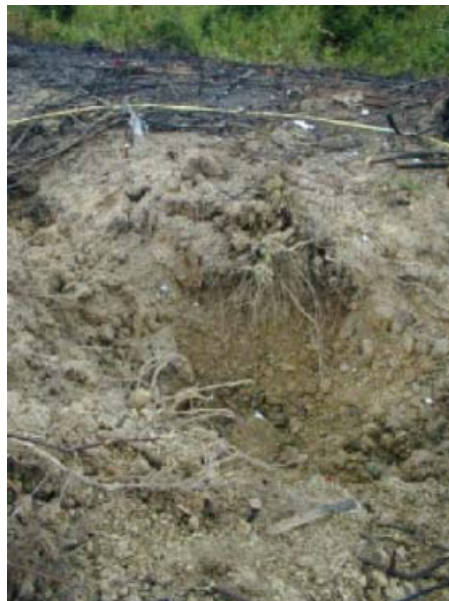
[The picture above shows the blast crater during the Accident Investigation.]

30. Crater is 2 metres in diameter and 1m into the depth. The bottom of the crater was very easy for the prodder to come through with all its working part (even to 25 cm into the depth). According to the information gathered on the site, Bol presume that the mine was 1 – 1.2 metres from the surface of the ground. Trenches that are connected with the accident site are as with the day of the investigation 30-40 cm deep. That leads the Bol to the presumption

that the mine was laid 60-70 cm from the surface. A possible position of the mine and the exact appearance of the crater found by the Bol are attached in annex. [Not made available.]

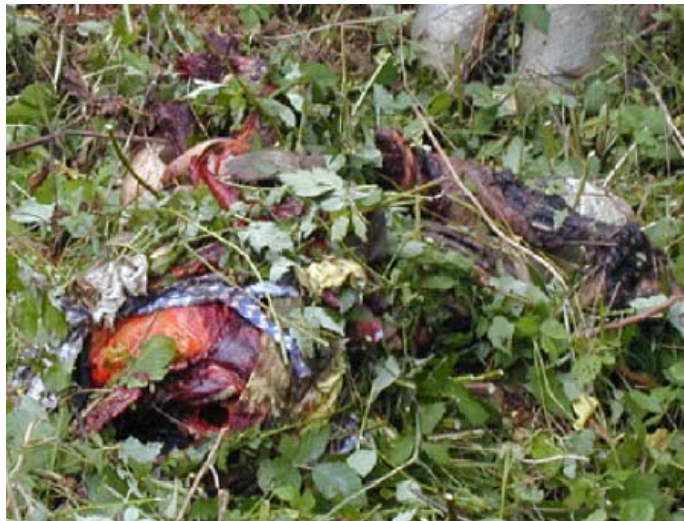
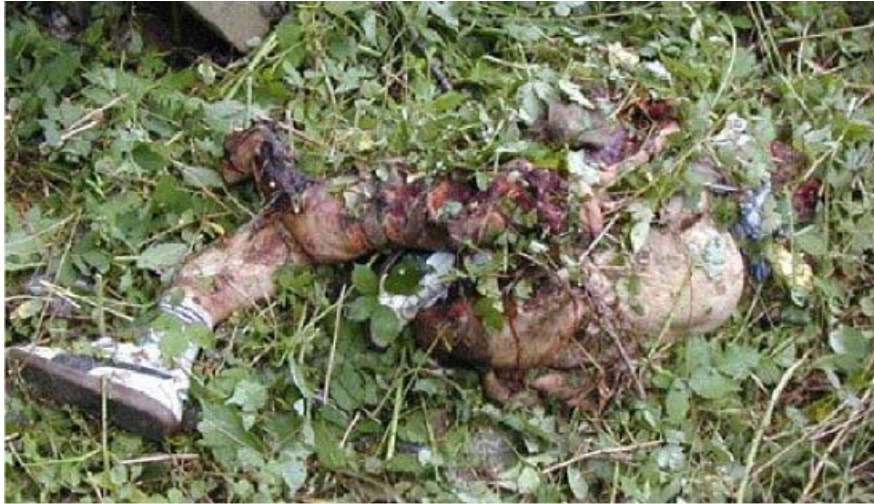
The pictures show Victim No.2 as he was discovered at the site.
