DDASaccident345

DDAS Accident Report

Report date: 19/05/2006	Accident number: 345
Accident time: 10:55	Accident Date: 17/03/2000
Where it occurred: Gluva Smokva, midway between Trebinje and Dubrovnik	Country: Bosnia Herzegovina
Primary cause: Field control inadequacy (?)	Secondary cause: Inadequate equipment (?)
Class: Missed-mine accident	Date of main report: 29/03/2000
ID original source: 1002-RB/BK/VMM/PB	Name of source: BiH MAC
Organisation: Name removed	
Mine/device: PMA-2 AP blast	Ground condition: bushes/scrub rocks/stones route (verge) soft
Date record created: 21/02/2004	Date last modified: 21/02/2004
No of victims: 1	No of documents: 1

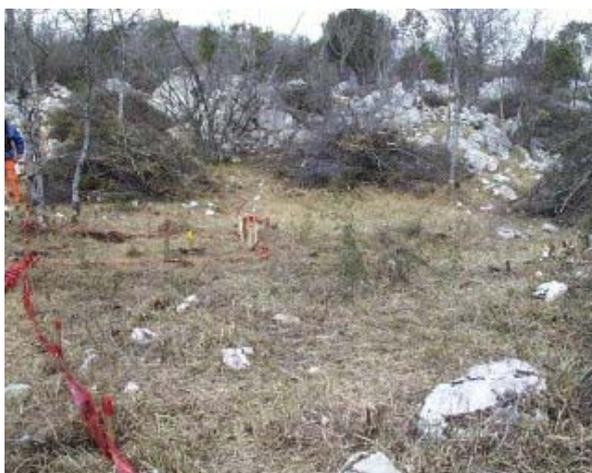
The accident occurred at approximately 120th metre of two metres wide safe lane (it is not possible to state is exactly since the safe lane is cut at places with big rocks and stone

There are yellow-tipped pickets in the lane where the previous mines were found (21 mines, 9 PMA-2 and 12 PMR-2A until the day of the accident. Accident happened up to two metres from the left edge of the safe lane, on the cleared area (missed mine).

[The accident site is shown above.]

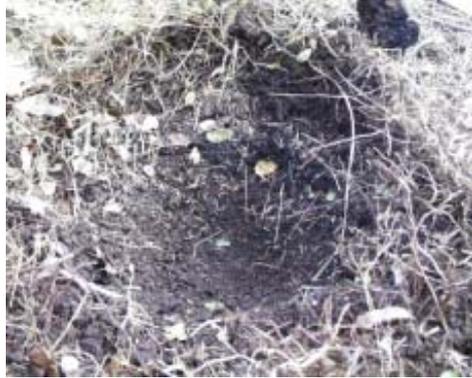
At the day of the accident it took a lot of force to prod into the depth of 8 cm, though it rained a day before and the ground was softened due to rain.

The item that led to the accident is, as supposed by the Bol members, an AP mine PMA-2 set to be pressure activated by stepping on its prong. Leftovers of the mine were not found. As stated by the Bol members, mine was buried into the ground at the depth of 11-12 cm measured from the top of the crater (there is a 5 cm high pile of grass cut long time ago). Crater itself is of the oval shape, 22 cm wide, 40 cm long and 15 cm deep. Two stones of the size of an egg were found inside the crater, where the explosion occurred.

[The crater was in soft, peaty soil as shown above.]

- 1) **Demining tools must NECESSARILY be adequate to the area being cleared.** The diameter and the sharpened end of the prodder must enable the deminer to prod without force in order to locate the item at the minimum depth of 10 cm.
