DDASaccident346

Humanitarian Demining Accident and Incident Database
AID

DDAS Accident Report

Report date: 19/05/2006	Accident number: 346
Accident time: 13:25	Accident Date: 09/03/2000
Where it occurred: Kopanice village, Nr Vidovice	Country: Bosnia Herzegovina
Primary cause: Field control inadequacy (?)	Secondary cause: Inadequate training (?)
Class: Missed-mine accident	Date of main report: 13/03/2000
ID original source: 1002 RB/NK/MM/VMM	Name of source: BiH MAC
Organisation: Name removed	
Mine/device: PROM-1 AP Bfrag	Ground condition: bushes/scrub grass/grazing area sparse trees
Date record created: 21/02/2004	Date last modified: 21/02/2004
No of victims: 1	No of documents: 1

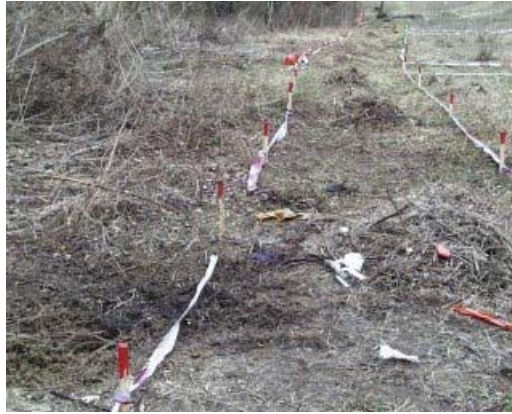
[The picture above shows the accident site before the investigator's arrived – it was taken by the police.]

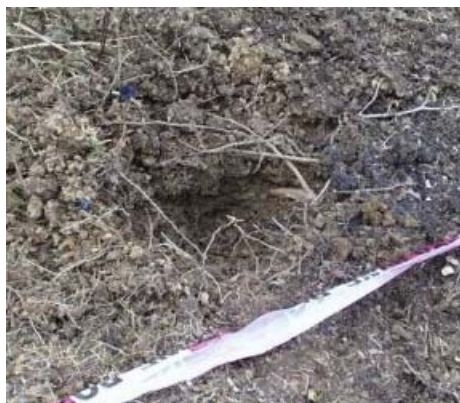
Accident spot (the imprint of the PROM mine plate) is 45 cms outside of the task, 19,15 metres from the edge of the top of the bank. The border of the task is marked with sticks while the tape is set after the accident.

[The picture above shows the crater and the distance from the "safe" area with the new tape placed before the investigator's arrived.]

Deminer had activated the mine by stepping on it (pressure) in the suspect area (plate imprint is 45 cm away from the tape connected to two stakes that are damaged by shrapnel.) The tape at the accident spot was attached to the stakes afterwards, additionally marking cleared and suspect area that is not within the task (the tape is not damaged by shrapnel).

The very place of the accident was disturbed and additionally marked. As stated before, the tape is not damaged by shrapnel, which can easily be seen from the photographs police have made. Lots of pieces of red tape were found near the place of the accident (used by [Demining group] in August 1999), though the bunch of the old red tape was found 31 metres away from the place of the accident.

It is stated in BH Standard that the place of the accident is to be closed and not to be touched in order to wait for the Board of Inquiry. It has to be the same as it was in the moment when the accident happened.

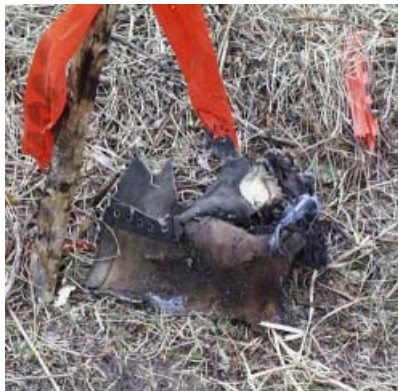
[The picture above shows one of the Victim's boots and scraps of marking tape.]

As stated by injured deminer as well as noticed at the spot (a bunch of old red tape 31 metre away from the accident, used in August 1999 by [the same Demining group] for marking cleared area) Board had concluded that the deminer was rolling the old tape. (Annex C – pieces of old red tape). The tape was most likely been cut near the accident spot. Deminer probably reached for the other part of the cut tape that was in the suspect area. Thus he himself stepped into the suspect area and activated a mine. There was no working lane in the vicinity in which demining was done at the moment.

Deminer had activated a PROM-1 mine on pressure (it was not possible to state if it was tripwired). Board of Inquiry agreed that deminer was taking off and rolling old tape that was with one part in the suspect area. He was not wearing protective equipment because “he was not demining”. He stepped out to fetch the other part of cut tape that was in the suspect area. It is not possible to explain why did he step from the cleared area that was (partially) marked. On the opposite side of the accident spot there were lots of pieces of red tape (used by [Demining group] company in August 1999) though the bunch of old red tape was found 31 metre away from the place of the accident.

There is a breaching of procedures: Never to step over the border between the clear and suspect area. This safety measure is stated in BH Standard.

Protective equipment **MUST** be worn in all the procedures of humanitarian demining from the very entrance onto the access lane (100 metres towards the minefield – BH Standard)
