# DDASaccident347

# DDAS Accident Report

<b>Report date:</b> 19/05/2006	<b>Accident number:</b> 347
<b>Accident time:</b> 08:55	<b>Accident Date:</b> 18/08/1999
<b>Where it occurred:</b> Stup II, Azici, Sarajevo	<b>Country:</b> Bosnia Herzegovina
<b>Primary cause:</b> Field control inadequacy (?)	<b>Secondary cause:</b> Management/control inadequacy (?)
<b>Class:</b> Detection accident	<b>Date of main report:</b> 25/08/1999
<b>ID original source:</b> RB/NH/IG/SD	<b>Name of source:</b> BiH MAC
<b>Organisation:</b> Name removed	
<b>Mine/device:</b> PROM-1 AP Bfrag	<b>Ground condition:</b> building rubble dry/dusty hard metal scrap residential/urban
<b>Date record created:</b> 21/02/2004	<b>Date last modified:</b> 21/02/2004
<b>No of victims:</b> 1	<b>No of documents:</b> 1

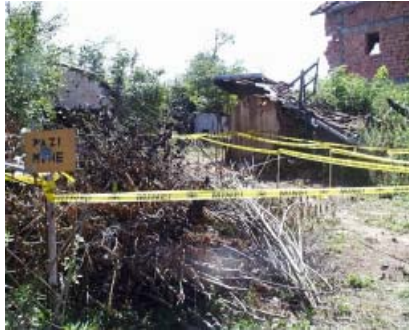
[The picture above shows the accident area.]

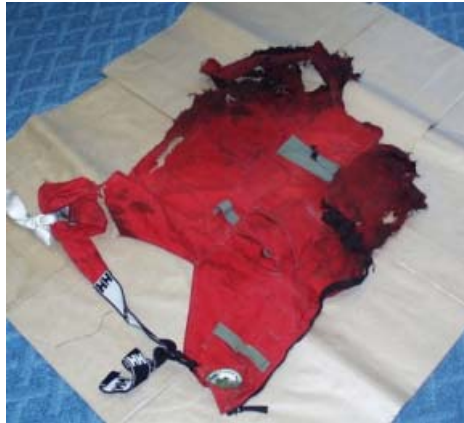
[The Victim's overall is shown above. It is upside down, so most damage occurred at the top of the legs, where it was shredded.]

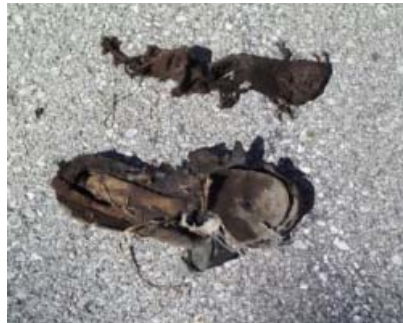
[The remains of one of the Victim's shoes is shown above, implying that he may have stepped on the mine and not detonated it with the detector head.]

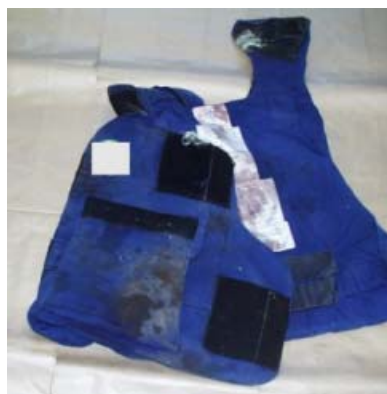
[The Victim's frag-vest is shown below. Fluffs of its Kevlar inner imply some penetrations.]

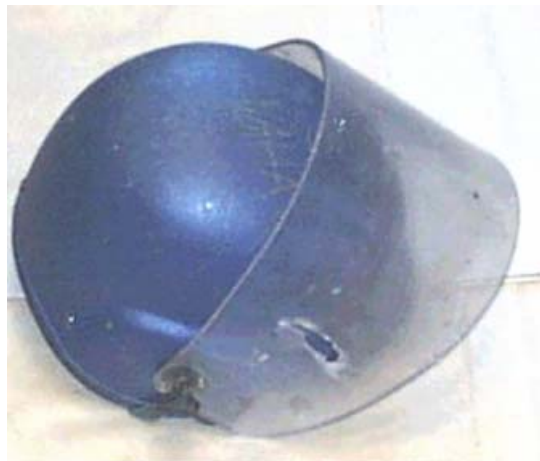
[The victim's helmet and visor (holed) is shown below.]

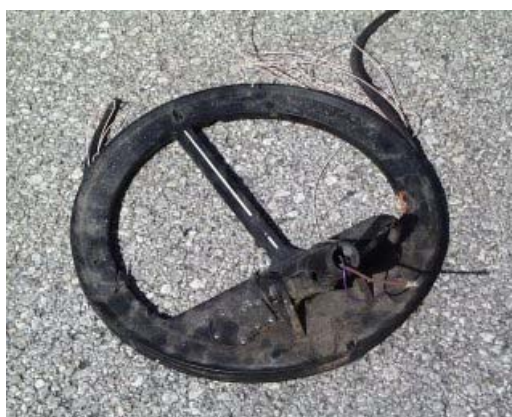
[The head of the victim's detector is shown above.]

36. Damages to the equipment helped in finding out the position of the deminer in the very moment of the accident.

50. Deminer had to enter with the MD's head between the turfs in order to sweep the area at the same height, with detector's head slanted. That was the only way to precisely locate the source of its signal, so he could have easily activated the fuse prongs of the PROM-1.

51. This assumption can be approved by the nature of the damages to the metal detector that was found near the working lane (Sketch at Annex C shows the places where pieces of MD were found, while the photographs at Annex G show the degree of damages to the

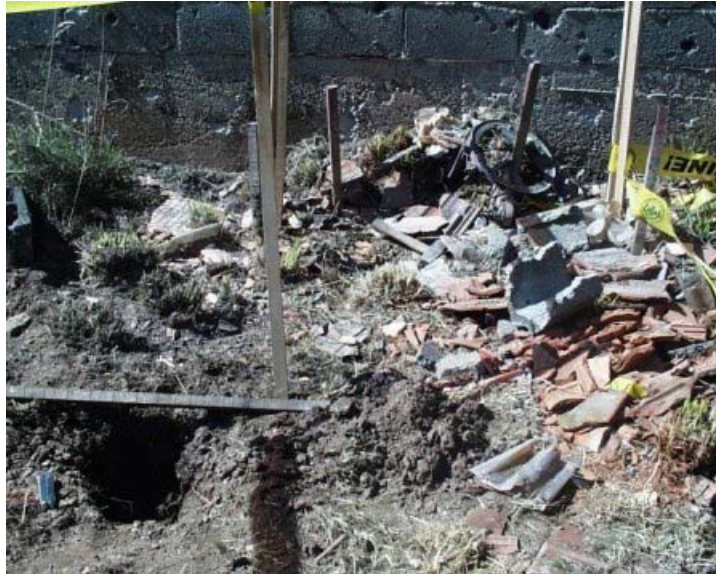
38. The PROM-1 detonated 20 (twenty) cms above the surface. (Easily spotted shrapnel in the wall of the nearby house. Photograph attached as Annex D.) [Not made available.]

[The picture shows the blast crater on the left, rubbish on the right.]
