DDASaccident349

Humanitarian Demining Accident and Incident Database
AID

DDAS Accident Report

Report date: 19/05/2006	Accident number: 349
Accident time: 09:45	Accident Date: 11/07/1999
Where it occurred: Sizje village, Lukavac municipality	Country: Bosnia Herzegovina
Primary cause: Field control inadequacy (?)	Secondary cause: Management/control inadequacy (?)
Class: Missed-mine accident	Date of main report: 15/07/1999
ID original source: RB/JG/NK/MB/VMM	Name of source: BiH MAC
Organisation: Name removed	
Mine/device: PROM-1 AP Bfrag	Ground condition: building rubble bushes/scrub metal scrap
Date record created: 21/02/2004	Date last modified: 21/02/2004
No of victims: 4	No of documents: 1

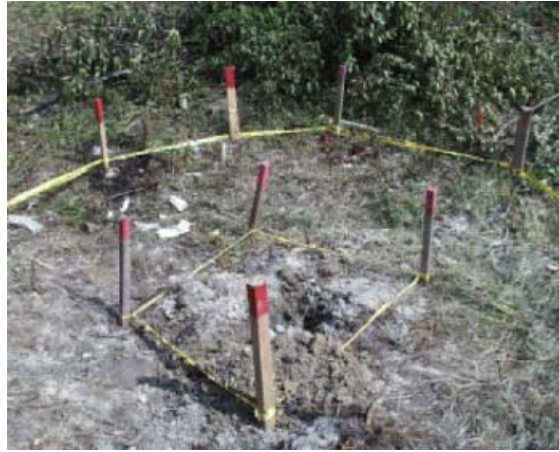
[The photograph above shows the accident site after the detonation.]

17.1 The accident occurred at a distance of 18.2m from the road – datum line, in the “cleared” area where the vegetation was very thoroughly removed by vertical cutting – using an axe. Accident happened when the sign for the break was given, while the deminers were leaving the minefield towards the Control point.

17.2 The cause of the accident is the PROM –1 mine activated with pressure.

18.3 Since the vegetation around the activated mine was removed, there is a reasonable doubt that the procedures of humanitarian demining were not followed.

18.4 If they were, a PROM-1 mine would have been found by any of the means of manual clearance.

It is strictly forbidden to use the tools for vertical cutting in removal of vegetation.

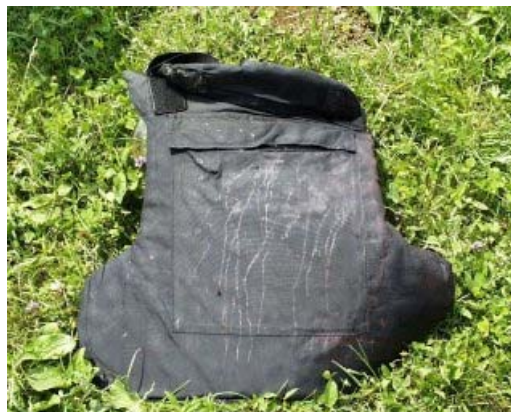
[The photograph above shows the medic’s frag-vest.]

9.4.2 [Victim No.4], the medic, was injured in his left arm so that two arteries were cut by a splinter.

14.0 Deminers were not wearing PPE when the accident occurred. None of the deminers' vests or helmets were damaged or stained with blood. Only the injured medic was wearing his PPE, which is damaged and stained with blood, but it stopped the medic from being injured even more severely.

No one is to be allowed to leave the Control Point or enter the minefield without a proper PPE, whether those were operating deminers or others.
