# DDASaccident353

# DDAS Accident Report

A Board of Inquiry (1301) 03/01 2001 was convened as a result of a mine strike on a Hydrema flail being operated by [two NGO's together] on 29 Sep 01 in Shilalo minefield ER246.

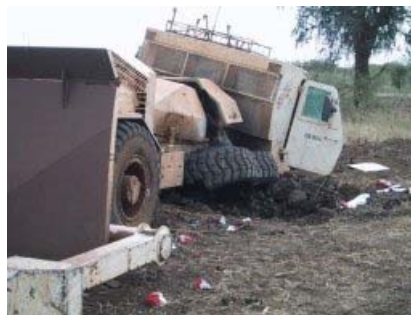
The picture above shows the machine after the blast.

1. The vehicle was severely damaged by the mine and may require factory repair before working again. This is disturbing as the mine was a common mine used throughout the world. This is in contradiction to the manufacturers claims (see Attachment K).

1. Damage was greater than should have been expected under the circumstances of the accident. The manufacturer claims a 2 to 6 hour repair cycle.

- a. The Hydraflail should be suspended from operations in AT minefields in UNMEE AOR until safety modifications are done and the machine is retested and certified to be suitable for use.

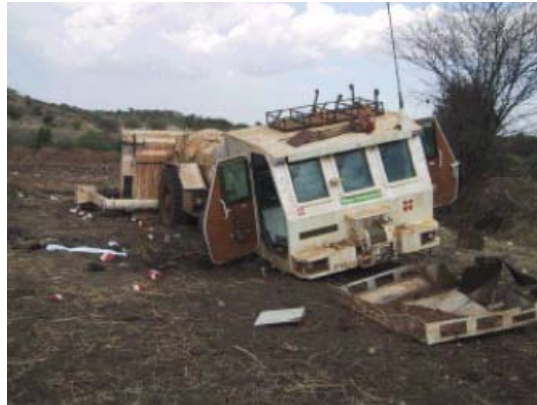
The picture above shows the front of the machine after the accident (it reverses into the mined area with the flail on the back).

4. One door lock had broken and, according to the Danish military team, this was experienced during blast trials in Denmark as well.
5. The vehicle had a supposed blast deflector underneath. However, this had been torn off and thrown clear of the vehicle. There seems to be some confusion as to whether this is just protection for the pipes under the vehicle or actually a blast protector.

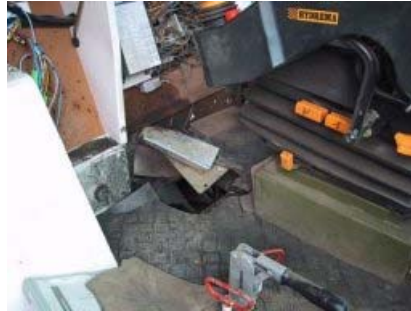
2. Protection to the operator was inadequate as shown by the blast penetration of the cab.
3. The vehicle needs strengthening in key places, primarily on the floor and door locks
4. The machine was determined to have passed only once over the ground where flailed and on the site the deepest penetration achieved by the flail was found to be only 100mm (4").
5. Should the vehicle have performed to the manufacturer's claimed standards or at least the national standards, the mine would have been destroyed by the flailing action and if it had missed the mine there should have been no injuries to the operator as a result of blast directly under the vehicle cab.

The picture above shows the floor of the cab where the steel plate covering the pedal-stem hole has lifted.

12. Unexpected damage to the vehicle included the relocation of the protective plate under the cabin, and loosening of the covering plate under the pedals inside the cabin. (It should be noted that no such damages were incurred during a previous worst case acceptance test, detonating 10 kg TNT under a corresponding wheel).

13. Injuries sustained by the driver included bruises, caused i.a. by loose objects in the cabin, and a broken heel, caused by the upward movement of the covering plate under the pedals.
