DDASaccident353

Humanitarian Demining Accident and Incident Database

DDAS Accident Report

A Board of Inquiry (1301) 03/01 2001 was convened as a result of a mine strike on a Hydrema flail being operated by [two NGO's together] on 29 Sep 01 in Shilalo minefield ER246.

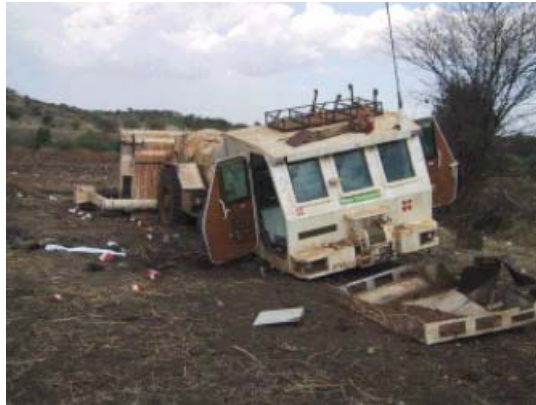
The picture above shows the front of the machine after the accident (it reverses into the mined area with the flail on the back).
