DDASaccident366

DDAS Accident Report

Report date: 15/03/2004	Accident number: 366
Accident time: 10:15	Accident Date: 16/11/2001
Where it occurred: Stajke Village	Country: Kosovo
Primary cause: Inadequate equipment (?)	Secondary cause: Unavoidable (?)
Class: Missed-mine accident	Date of main report: 24/11/2001
ID original source: TKG	Name of source: KMACC
Organisation: Name removed	
Mine/device: PMA-3 AP blast	Ground condition: bushes/scrub rocks/stones route/path woodland (light)
Date record created: 21/02/2004	Date last modified: 21/02/2004
No of victims: 1	No of documents: 1

Accident report

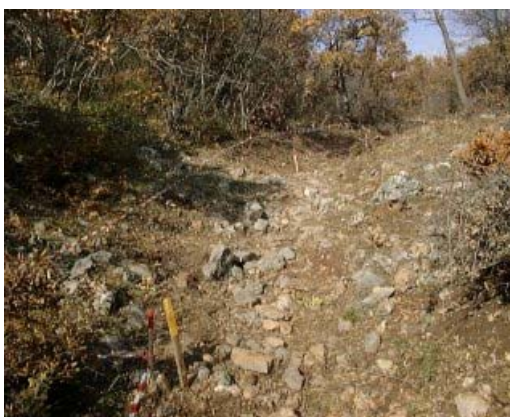
The seat of the explosion was at a distance of 80cm from the centre of the track and plainly inside the cleared area. There are numerous rocks and boulders within this area, and on investigation of the blast hole it was apparent from the indentation in the ground that the rock was approximately 40cm x 40cm. It could not be determined how thick the rock was, as it had been completely destroyed.

[The picture above shows the accident lane.]

Considering that the area in which this mine was laid had been cleared four days previously, it is quite possible that other people have walked over this rock without detonating the mine. There is no identifiable pattern of mines in this area of the accident site. This therefore makes it very difficult when determining where the mines could be laid.

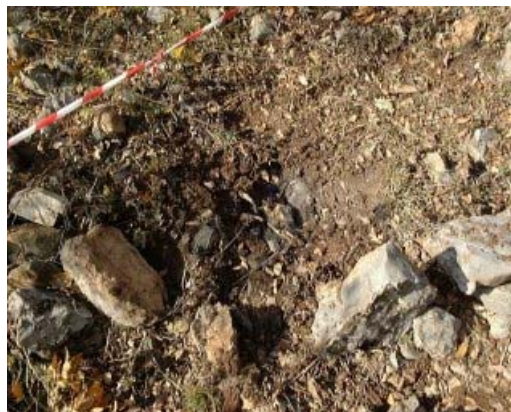
The indentation of the rock that was above the mine could still be seen in the ground during the investigation. The approximate surface area of the rock was 40cm x 40cm. The rock took the bulk of the blast from the mine, which prevented [the Victim] from receiving serious injuries and possible traumatic amputation of his foot.

The investigators did not detail the manner in which they determined the depth of the mine. Other mines found beneath rocks had not been deeply buried. If a large rock was above it, it is likely that the detonation would have disrupted the ground more than it would have otherwise and so the mine may not have been laid as deeply as the investigators supposed. Any PMA-3 laid at that depth would not necessarily detonate when the ground above it was traversed, so there would have been little point in laying the mine so deeply.

The crater at the accident site is shown below.

Removing all rocks is seen as a very inefficient clearance option. The number of mines found under rocks in comparison to the total number of mines located and destroyed does not merit the total removal of all rocks. However there does need to be a compromise to ensure that no further mines are missed and the efficient and effective clearance standard that is required. It is therefore recommended that [Demining group 1] continue with their method of manual clearance, however there is a need to make a more thorough appraisal of rocks that could potentially conceal a mine. These rocks will need to be investigated.

[Demining group 1] are to revisit all their areas cleared in this minefield to date and re-assess rocks that were not moved, in order to investigate potential mines that could be concealed beneath them.
