DDASaccident367

DDAS Accident Report

Report date: 15/03/2004	Accident number: 367
Accident time: 14:25	Accident Date: 25/09/2001
Where it occurred: MNB West, Kurvala Region, Albania border	Country: Kosovo
Primary cause: Victim inattention (?)	Secondary cause: Field control inadequacy (?)
Class: Victim inattention	Date of main report: 09/10/2001
ID original source: 014/2001	Name of source: KMACC
Organisation: Name removed	
Mine/device: PMA-3 AP blast	Ground condition: grass/grazing area rocks/stones
Date record created: 21/02/2004	Date last modified: 15/03/2004
No of victims: 1	No of documents: 1

The MACC carried out a Board of Inquiry and made its report available in early 2002. The report is reproduced below, edited for anonymity.

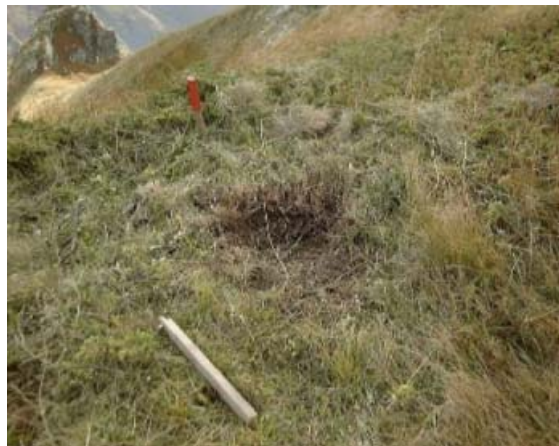
This finding is based on the fact that at the time of the accident the [Victim] placed his left foot outside the cleared area and detonated a PMA-3 Anti Personnel Blast Mine.

[The picture below shows the accident site and the blast hole The marking is use is "cursory".]

- The exact position of the base stick in relation to the uncontrolled detonation cannot be determined as it was destroyed in the blast. However the fact that it was destroyed indicates that it must have been in very close proximity to the explosion.

- A PMR2A was visible 70cm past the blast hole. This may have been a distraction to [the Victim] as he was clearing toward it. It appears he has not concentrated and taken due care whilst conducting his manual clearance drill.

The primary cause of this accident is listed as "*Victim inattention*" because it seems that the victim inadvertently stepped over his base stick as he turned. However, the damage to the base stick may indicate that the mine was beneath it and had so been missed during clearance. If so, the systems in place allowed the base stick to be moved beyond the cleared area, which would be a "*Field control*" inadequacy. The cursory area-markings in use may have been a contributory cause of the deminer's mistake.

- The [Demining group] teams in the Kurvala region that are supported by German KFOR CASEVAC helicopters are to establish and maintain direct radio communications on an hourly basis during operations, and are to communicate directly for helicopter CASEVACs.
- [Demining group] management and supervisory staff are to re-emphasise to their deminers the need to maintain concentration and focus whilst conducting manual clearance drills. [Demining group] team leaders are to be extra vigilant to ensure their deminers are conducting their clearance drills effectively and safely.
- The German KFOR be commended for their CASEVAC and medical support in difficult conditions.

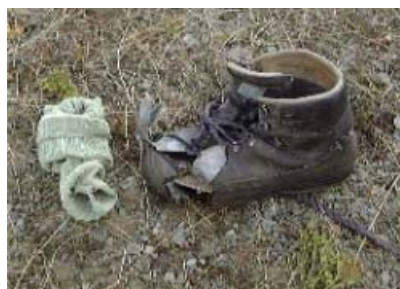
[The picture below shows the victim's boot and sock.]

The initial injuries that Deminer [Victim] suffered were deep lacerations and broken bones to his left foot. After arriving at the German KFOR hospital the doctors have amputated two of his toes with the possibility of another toe being amputated at a later date.
