DDASaccident367

Humanitarian Demining Accident and Incident Database

DDAS Accident Report

Report date: 15/03/2004	Accident number: 367
Accident time: 14:25	Accident Date: 25/09/2001
Where it occurred: MNB West, Kurvala Region, Albania border	Country: Kosovo
Primary cause: Victim inattention (?)	Secondary cause: Field control inadequacy (?)
Class: Victim inattention	Date of main report: 09/10/2001
ID original source: 014/2001	Name of source: KMACC
Organisation: Name removed	
Mine/device: PMA-3 AP blast	Ground condition: grass/grazing area rocks/stones
Date record created: 21/02/2004	Date last modified: 15/03/2004
No of victims: 1	No of documents: 1

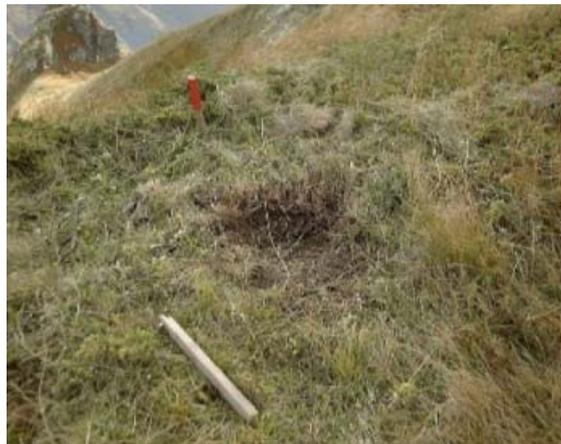
This finding is based on the fact that at the time of the accident the [Victim] placed his left foot outside the cleared area and detonated a PMA-3 Anti Personnel Blast Mine.

[The picture below shows the accident site and the blast hole The marking is use is "cursory".]

- The exact position of the base stick in relation to the uncontrolled detonation cannot be determined as it was destroyed in the blast. However the fact that it was destroyed indicates that it must have been in very close proximity to the explosion.

- A PMR2A was visible 70cm past the blast hole. This may have been a distraction to [the Victim] as he was clearing toward it. It appears he has not concentrated and taken due care whilst conducting his manual clearance drill.

The primary cause of this accident is listed as "*Victim inattention*" because it seems that the victim inadvertently stepped over his base stick as he turned. However, the damage to the base stick may indicate that the mine was beneath it and had so been missed during clearance. If so, the systems in place allowed the base stick to be moved beyond the cleared area, which would be a "*Field control*" inadequacy. The cursory area-markings in use may have been a contributory cause of the deminer's mistake.

- The [Demining group] teams in the Kurvala region that are supported by German KFOR CASEVAC helicopters are to establish and maintain direct radio communications on an hourly basis during operations, and are to communicate directly for helicopter CASEVACs.
- [Demining group] management and supervisory staff are to re-emphasise to their deminers the need to maintain concentration and focus whilst conducting manual clearance drills. [Demining group] team leaders are to be extra vigilant to ensure their deminers are conducting their clearance drills effectively and safely.
- The German KFOR be commended for their CASEVAC and medical support in difficult conditions.

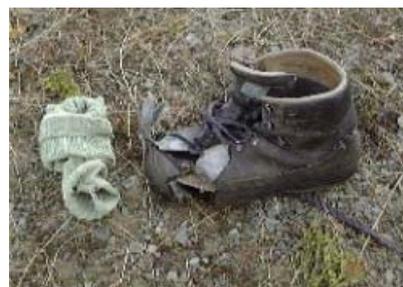
[The picture below shows the victim's boot and sock.]

- There was an uncontrolled detonation of a PMA3 anti-personnel mine on Tuesday 25 September 2001 in [Demining group] minefield number 431 situated in the Kurvala region of Kosovo. It appears [the Victim] inadvertently placed the outside of his left foot on the mine as he was turning to take up his metal detector.

- [The victim] initially suffered deep lacerations and broken bones to his left foot as a result of the uncontrolled detonation. He has since had two toes of his left foot amputated by the German KFOR doctors in Prizren.
