DDASaccident368

Humanitarian Demining Accident and Incident Database
AID

DDAS Accident Report

Report date: 02/07/2014	Accident number: 368
Accident time: 10:30	Accident Date: 18/03/1993
Where it occurred: Chana Pale, Xangongo, Cunene Province	Country: Angola
Primary cause: Inadequate equipment (?)	Secondary cause: Field control inadequacy (?)
Class: Missed-mine accident	Date of main report: [None]
ID original source: HE/HGK	Name of source: HE/HGK/Others
Organisation: [Name removed]	
Mine/device: TM57 AT blast	Ground condition: agricultural (abandoned) bushes/scrub sparse trees wet
Date record created: 21/02/2004	Date last modified: 02/07/2014
No of victims: 1	No of documents: 1

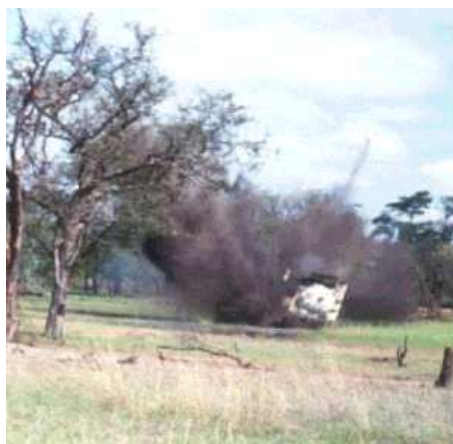
The tank continued forwards for a few seconds through approximately 20cm depth of mud with its underside in contact with the ground or shallow water. A mine was initiated underneath the middle of the inner side of the left track of the tank, a position which implies that the mine may have been already under the track when [Victim No.1] boarded the tank. The rotating base-plate, without the support of the gun, flipped up inside the tank. The round, rotating-disk base-plate was more than a metre in diameter and about 15mm thick steel. There was a 60cm long and 10cm wide breach in the armour parallel to the left track. The second to last wheel on that side was blown 50m away. The tank and roller system (weighing 35 tons) was lifted high into the air.

The picture below shows the tank standing almost on end when the detonation occurred. Captured on slide-media, it is very poorly detailed.

When the interior of the tank was examined in 2003, the grenade damage had left it impossible to determine how much damage had been done by the AT mine, and how much by the later "demolition". The large rent in the hull beside the missing wheel was visible, as was the deformed turret base-plate. The driver's bay was clearly in the path of the incoming AT blast.

The area around and beneath the tank should be cleared manually. This will involve moving the tank to a cleared area. The area cleared should be properly recorded and that record passed to the Angolan National Authorities so that further confusion over what has been done in the area can be avoided.
