# DDASaccident371

Humanitarian Demining Accident and Incident Database  
*AID*

# DDAS Accident Report

<b>Report date:</b> 15/03/2004	<b>Accident number:</b> 371
<b>Accident time:</b> 10:55	<b>Accident Date:</b> 06/04/2001
<b>Where it occurred:</b> Grebnik, S.E. Klina	<b>Country:</b> Kosovo
<b>Primary cause:</b> Field control inadequacy (?)	<b>Secondary cause:</b> Other (?)
<b>Class:</b> Excavation accident	<b>Date of main report:</b> 18/04/2001
<b>ID original source:</b> MF/LL/AH/JF No.001/2001	<b>Name of source:</b> KMACC
<b>Organisation:</b> Name removed	
<b>Mine/device:</b> BLU-97 submunition	<b>Ground condition:</b> agricultural (recent) grass/grazing area soft trees
<b>Date record created:</b> 21/02/2004	<b>Date last modified:</b> 21/02/2004
<b>No of victims:</b> 2	<b>No of documents:</b> 2

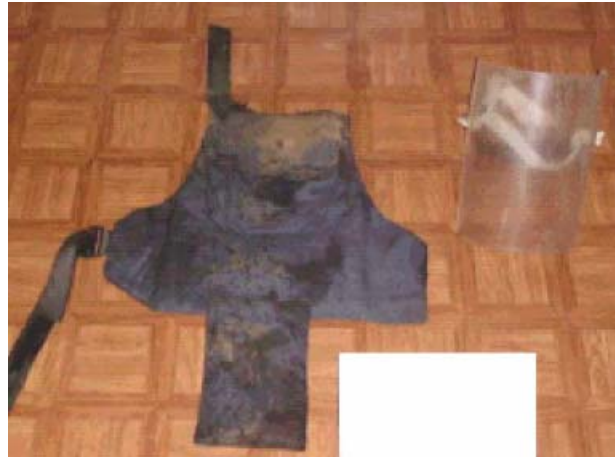
26) At the time of the accident both BAC deminers were wearing protective jackets, it is not known, nor is it possible at this time to conclude whether the BAC deminers were wearing their visors. This however has no bearing on the investigation, as the break had been called and in accordance with [Demining group] SOPs, visors can then be removed.

[Photographs showed damaged armour but visors undamaged, therefore not worn.]

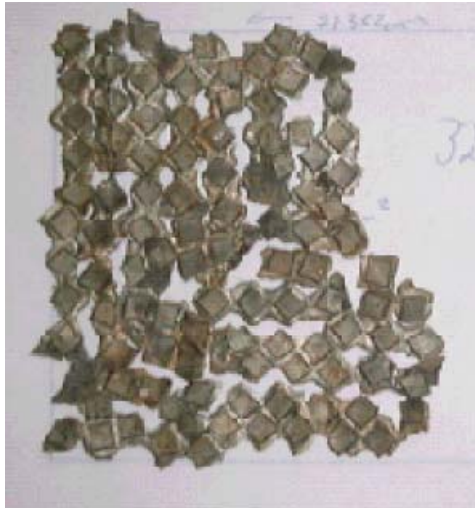
[The picture below shows recovered fragments from the crater.]

- There was a sub-surface detonation of a BLU-97 sub-munition. Evidence shows that the crater had heavy blackening to the sides, was of a bulbous shape with fragmentation lining the sides. Also a camouflet had formed 360 degrees around the edges, with the debris on the North Western side spread farther out than on the other sides (direction of the plasma jet). The crater size was 70 cm in diameter and 45cm at the deepest point. This is considerably larger than a crater that would be formed by a surface detonation of a BLU-97 sub-munition.

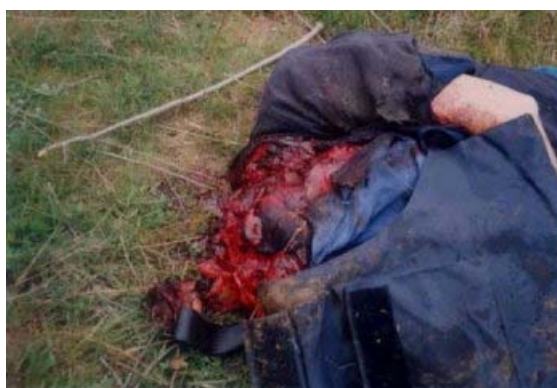
- The plasma jet of the BLU-97 sub-munition decapitated and subsequently killed [Victim No.1] as it moved out from the seat of detonation in a North Westerly direction. It was also the concentrated directional blast effect from the plasma jet that lifted his body and carried it the distance of 12m, to the North West location where it was later found.

The photograph below shows destruction of Victim No.1's head. Others showed severe hand and arm injuries.
