# DDAS Accident Report

### REPORT FOR ACCIDENT INVESTIGATION BOARD OF INQUIRY – No 012/2001

Mine Accident that occurred in MNB West on Tuesday 28 August 2001 in which [the Demining group's] Task Site Leader [the Victim] was injured.

- 4) The accident occurred at one of the Rasa Koshare minefield's, Task Dossier Number W02-37, minefield number 315, GR 34T DN 34963 01785 on 28 August 2001 at 09:35 hours.

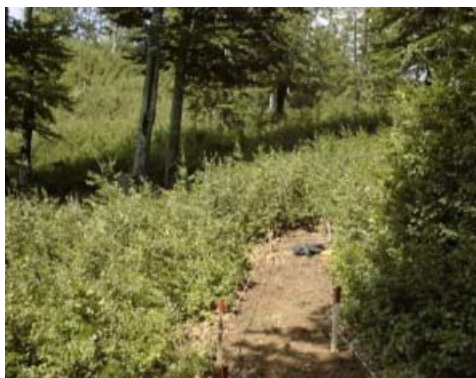
11) Upon investigation it was apparent that [the Victim] had cleared the surface leaves away where he placed his feet as he walked out into the uncleared area. There was no evidence of any marking or other approved methods of clearance where [he] had walked.

[The picture above shows the accident lane. The accident happened in front of the cleared area.]

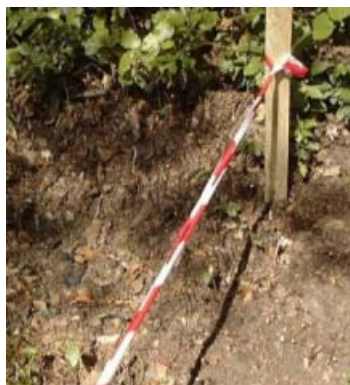
10) The seat of the explosion was at a distance of approximately 10m from the end of the clearance lane. Therefore in order to safely continue the investigation, an access lane was manually cleared to the location of the explosion. There was evidence at the seat of explosion that the mine involved was a PMA3 anti-personnel blast mine.

[The photograph below shows the seat of explosion after a lane had been cleared to the place.]
