### DDASaccident373

# DDAS Accident Report

REPORT FOR ACCIDENT INVESTIGATION BOARD OF INQUIRY – No 016/2001

Mine Accident that occurred in MNB West on Sunday 30 September 2001.

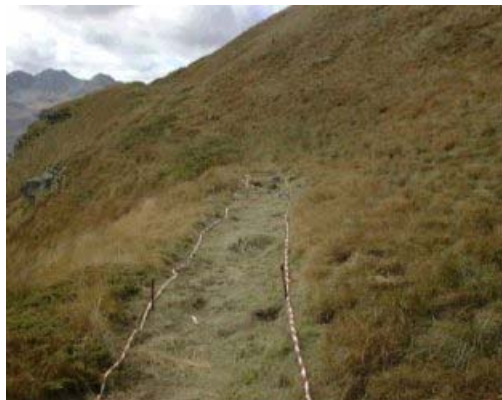
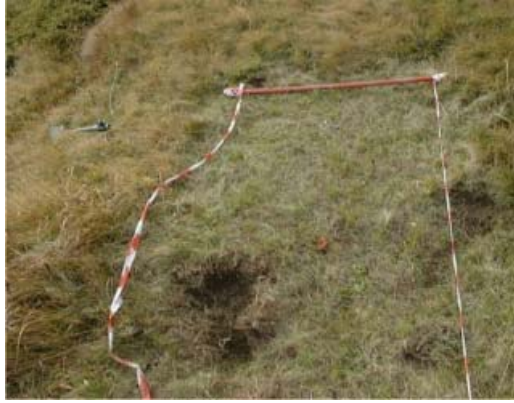
9) The MACC QA Officer along with [the Demining group's] Programme Manager (ITF Contract) [name excised] commenced the investigation the following day. The accident site had been left untouched since the time of the accident. The blast hole was approximately 1.5m before the base stick in the cleared lane. The metal detector was severely damaged in the blast. The search head had been detached from the shaft and control box as a result of the explosion. Deminer A had left the detector next to the left side mine tape of the clearance lane when he returned to the rest area. The detector was beside [the Victim's] left knee as he knelt and was therefore caught in the blast.

10) The shape of the blast hole is not consistent with a single PMA3 explosion. Deminer A has stated that he did not conduct any excavation in the vicinity of the mine that [the Victim] knelt on. There is a possibility that there may have been two mines involved in the blast due to the shape and size of the hole. The depth of the blast hole was not indicative of a deeply laid mine.

Views of the accident site and blast crater are reproduced below. The site is within 25 metres of the accident that occurred on 25<sup>th</sup> September 2001.

[The lane marking does not include the use of regular stakes/posts and so its precise location can be moved by wind.]

The Victim was in the process of getting into the prone position in order to remove the PMA3 located by Deminer A when he knelt on the another PMA3 in the cleared lane. This mine was not located and was therefore missed by Deminer A. The Vallon Metal Detector was next to the mine marking tape to the left of the lane. From the explosion the shaft was shattered and the detector was in two pieces with the control box part way down the hill and the search head in the lane.

Deminer A during his shift had located 4 x PMA3 mines. Two of the mines positions were marked with mine sticks, the third was knocked over during the CASEVAC. The three mines numbered 1 - 3 were all dealt with in the same manner with [the Victim] removing them and placing them in the mine collection area. The fourth mine was about to be dealt with in the same way when he knelt on the fifth mine that was undetected by Deminer A.

Although the investigator did not identify it as a cause, the photographs he took during the investigation show that lane marking was potentially imprecise and used a method that would not have been acceptable to many demining groups, and is not as recommended in the IMAS.

- [The Demining group] management takes the appropriate disciplinary action against Deminer A for this very serious breach of clearance standards that has caused this most unfortunate accident.
- [The Demining group] management and supervisory staff are to re-emphasize to their deminers the need to maintain concentration and due care whilst conducting manual clearance drills. The [Demining group] team leaders are to be extra vigilant to ensure their deminers are conducting their clearance drills effectively and safely.
