### DDASaccident374

# DDAS Accident Report

### REPORT FOR ACCIDENT INVESTIGATION BOARD OF INQUIRY – No 010/2001

Mine Accident that occurred in MNB West on the 31<sup>st</sup> July 2001

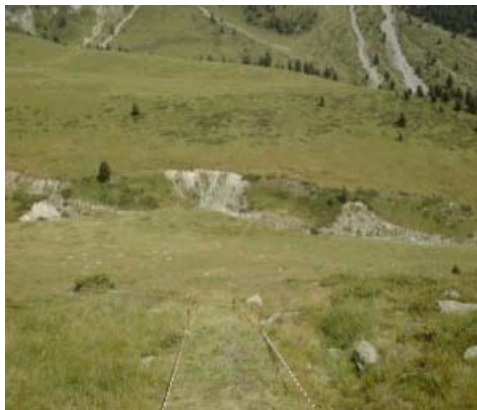
[The picture above shows the safe lane leading to the gully where the accident occurred.]

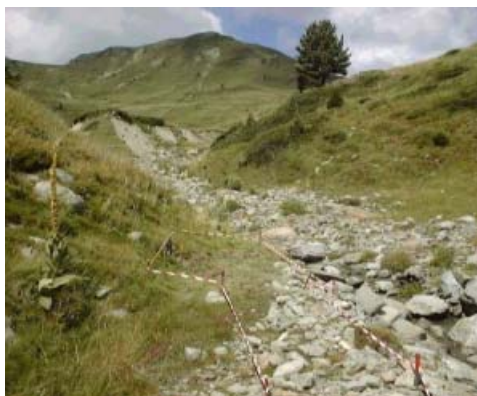
7) At approximately 08:40 hrs whilst Deminer [name excised] was either investigation a previously identified signal with his probe, or attempting to move a rock with his probe, an uncontrolled detonation of a PMA-3 anti-personnel blast mine occurred.

[Photograph of the accident lane – the accident site is in the middle of the picture where the marking tape ends.]

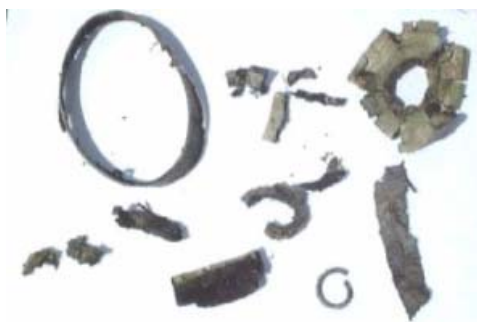
PMA-3 parts located at the site.

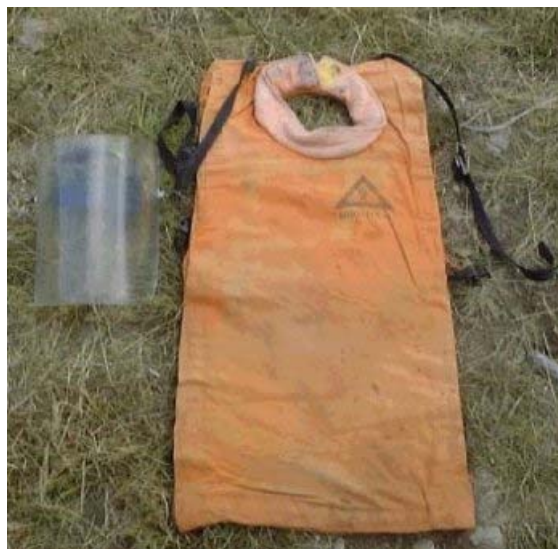
21) At the time of the accident all personnel working in the mined area were wearing PPE. Following the accident all items of PPE were removed and cleaned by [the Demining group]'s personnel. On inspection of the PPE the following day, the only damage sustained was to the left hand glove.

The victim's PPE is shown above.

The body armour apron used by the demining group is made of ballistic aramid and has a NATO STANAG V50 rating of 380 m/s (as opposed to the 450 m/s recommended in the IMAS). The lower rating and the more flexible material have proven effective against blast mines in more than 25 excavation accidents listed in this database.

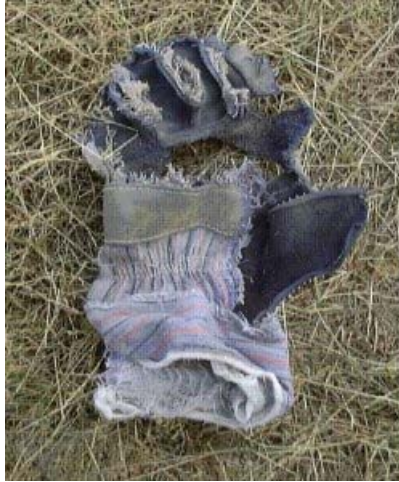
The victim's left glove is shown above.

Note the fact that the gardening glove provided no protection to his left hand. If the deminer was right handed, the left hand would have been guiding the probe and would have been far closer to the detonation than the right hand. This may be especially true when trying to move rocks with a probe. There is no record of which hand the deminer favoured.
