# DDASaccident380

# DDAS Accident Report

<b>Report date:</b> 19/05/2006	<b>Accident number:</b> 380
<b>Accident time:</b> 12:10	<b>Accident Date:</b> 20/07/2002
<b>Where it occurred:</b> Shama Village, Wadi Jalali ash Sharq	<b>Country:</b> Lebanon
<b>Primary cause:</b> Management/control inadequacy (?)	<b>Secondary cause:</b> Inadequate equipment (?)
<b>Class:</b> Demolition accident (survey)	<b>Date of main report:</b> 09/08/2002
<b>ID original source:</b> BOI:No007/2002	<b>Name of source:</b> MACC SL
<b>Organisation:</b> Name removed	
<b>Mine/device:</b> No.4 Israel AP blast / frag	<b>Ground condition:</b> grass/grazing area rocks/stones
<b>Date record created:</b> 22/02/2004	<b>Date last modified:</b> 17/03/2004
<b>No of victims:</b> 1	<b>No of documents:</b> 3

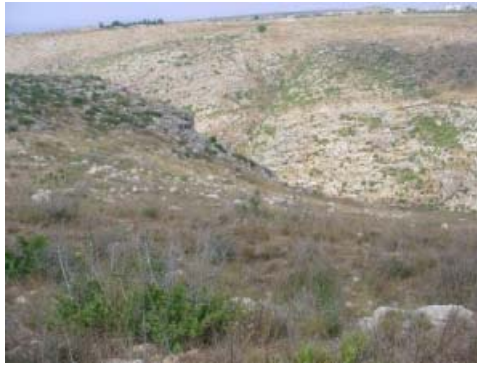
View of the mined area.

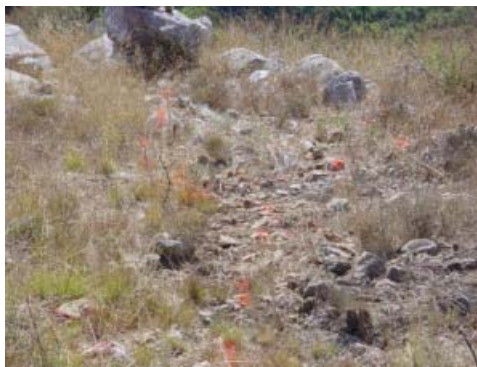
8. At approximately 12:10 hrs an uncontrolled detonation occurred in M/F 135A, following the uncontrolled detonation the Team Medic moved forward from the FP carrying his trauma pack and a metal detector. On arrival of the Team Medic at the BM, the Team 2i/c started to clear a route into and around the casualty from the BM, (the emergency marking used was orange spray paint).

[Emergency marking with spray paint. It seems that no marking was used until after the accident.]

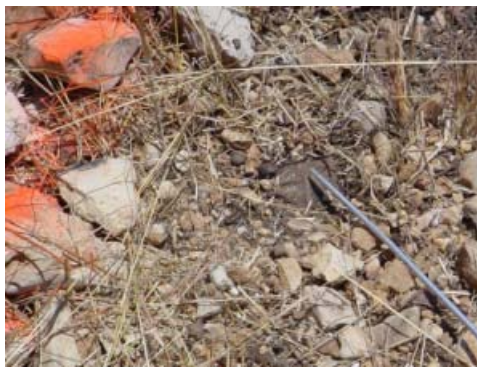
- The missed Israeli No.4 mine was inside the emergency area cleared by the Team 2i/c. Should someone in the extraction party unintentionally stood on the mine, then the accident would have been compounded significantly, with the possible loss of life being the outcome.

[Demining group emergency marking on the wrong side of the missed mine – beneath the tip of the prodder.]

The accident that resulted in Mr [the Victim]’s injuries are tragic, however the missed mine located 10cm from the marked route into his accident location are a reminder that this tragic accident could have been far worse. It took 6 men (4 local personnel not involved in the “Demolition Rapid Response Task” ), 55 minutes to move 1 casualty 109 metres and this was achieved with great difficulty, a second accident caused by the narrowly missed mine
