### DDASaccident380

HD-AID

# DDAS Accident Report

<b>Report date:</b> 19/05/2006	<b>Accident number:</b> 380
<b>Accident time:</b> 12:10	<b>Accident Date:</b> 20/07/2002
<b>Where it occurred:</b> Shama Village, Wadi Jalali ash Sharq	<b>Country:</b> Lebanon
<b>Primary cause:</b> Management/control inadequacy (?)	<b>Secondary cause:</b> Inadequate equipment (?)
<b>Class:</b> Demolition accident (survey)	<b>Date of main report:</b> 09/08/2002
<b>ID original source:</b> BOI:No007/2002	<b>Name of source:</b> MACC SL
<b>Organisation:</b> Name removed	
<b>Mine/device:</b> No.4 Israel AP blast / frag	<b>Ground condition:</b> grass/grazing area rocks/stones
<b>Date record created:</b> 22/02/2004	<b>Date last modified:</b> 17/03/2004
<b>No of victims:</b> 1	<b>No of documents:</b> 3

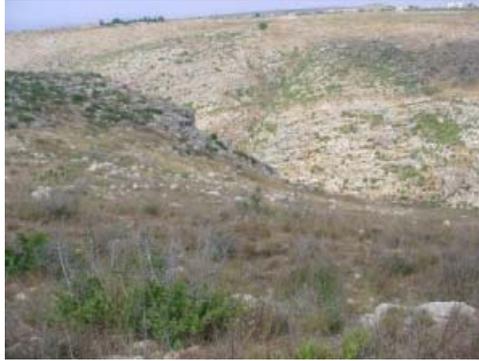
View of the mined area.

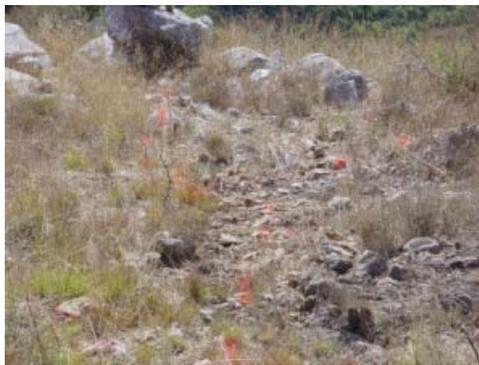
- The on-site marking in both M/F 135 and M/F 135A conducted on the 17.07.02 was not in accordance with [1st commercial demining group] SOPs, National TSGs or IMAS.

[Emergency marking with spray paint. It seems that no marking was used until after the accident.]

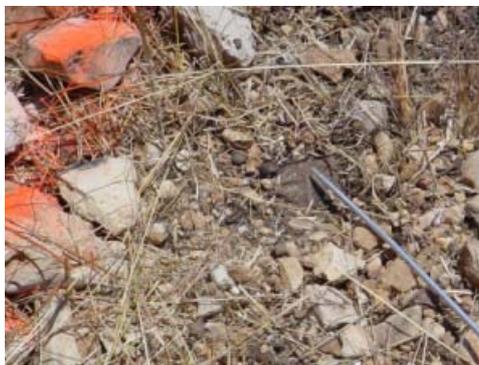
- The missed Israeli No.4 mine was inside the emergency area cleared by the Team 2i/c. Should someone in the extraction party unintentionally stood on the mine, then the accident would have been compounded significantly, with the possible loss of life being the outcome.

[Demining group emergency marking on the wrong side of the missed mine – beneath the tip of the prodder.]

The accident that resulted in Mr [the Victim]’s injuries are tragic, however the missed mine located 10cm from the marked route into his accident location are a reminder that this tragic accident could have been far worse. It took 6 men (4 local personnel not involved in the “Demolition Rapid Response Task” ), 55 minutes to move 1 casualty 109 metres and this was achieved with great difficulty, a second accident caused by the narrowly missed mine
