DDASaccident381

Humanitarian Demining Accident and Incident Database

DDAS Accident Report

REPORT FOR ACCIDENT INVESTIGATION BOARD OF INQUIRY – No005/2002

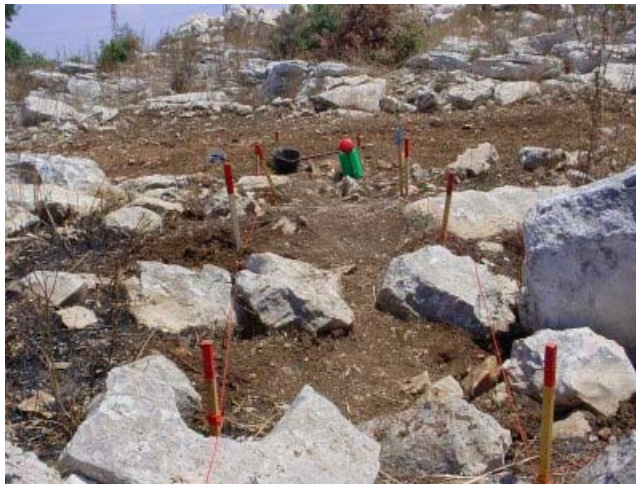
The area of the accident.

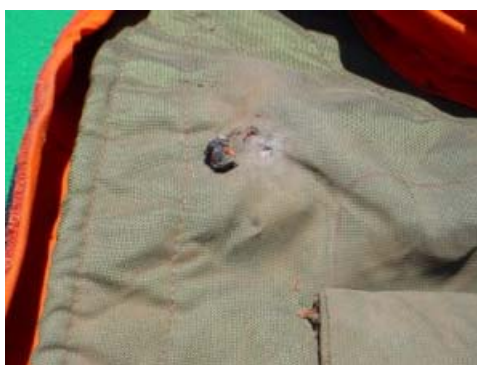
[The Victim's] apron

24. At the time of the accident, Deminer [the Victim] was wearing his protective apron and protective visor. On inspection of the protective apron, the following points were noted:

- The outer cover was ripped several places.
- The blast debris and damage was concentrated at top right hand side.
- There was part fragmentation penetration of the Kevlar lining.
- There was not full penetration of the Kevlar lining.

[The apron is not made of Kevlar, but ballistic aramid.]

[The cotton cover was torn and fragments trapped between it and the aramid behind. There are 16 layers of aramid material in this apron. The picture does not show a full penetration of even one layer.]

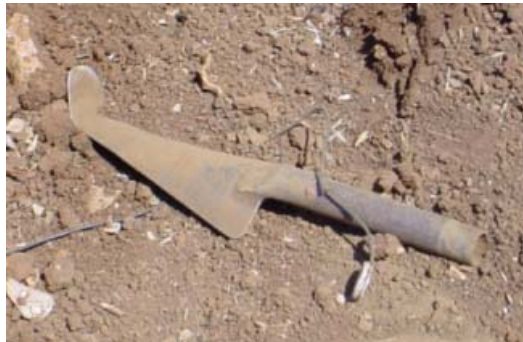
- The mine detonated whilst the Deminer was attempting to excavate it, detonation occurred through excessive indirect pressure application of the trowel tip, the deformation of the trowel tip substantiates this.

- At the time of the uncontrolled detonation, the mine would have been below the location of the trowel, the deformation of the trowel lower side substantiates this.

- The trowel was not in direct contact with the mine when it detonated as there is no melting of the trowel body.
- The BOI is not convinced that the ground was wetted prior to the excavation of the second signal, as all areas in and around the seat of detonation was found to be dry. It is appreciated that a large proportion of the water would evaporate on the detonation of the high explosive fill, but some evidence should remain if 6 x litres of water was used!

The investigator stated that the “detonation occurred through excessive indirect pressure application of the trowel tip, the deformation of the trowel tip substantiates this”. This is not true. A mild steel trowel placed on top of an AP blast mine without pressure will still be deformed in an HE blast. Also, the investigator should be aware that “melting of the trowel body” does not occur when in direct contact with a mine – although mild steel is likely to burn when in direct contact with a high explosive itself. The No.4 mine body is half void, and the HE block does not reach the lid even when the mine is closed (on detonation), so the absence of melting or burning does not imply a lack of contact between the tool and the mine casing.

26. At the time of the accident, a standard [Demining group] excavation trowel was being used by Deminer [the Victim]. On inspection of the trowel the following points were noted:

- The tip of the trowel had misshapen at an angle of 80 degrees from the norm.
- Deformation of the trowel was also present on the trowel body.
- The rubber handle bung had come away from the trowel.
- There were no signs of melting on the trowel.

[The use of this trowel for excavating and prodding is criticised in other accidents involving this demining group in this database. The trowel itself is not appropriately designed (not in line with IMAS guidelines) and has killed at least one deminer.]

- Some thought and consideration is given by [1st commercial demining group] to re-introduce the use of demining probes, as part of the Deminers toolbox.
