DDASaccident383

DDAS Accident Report

Report date: 19/05/2006	Accident number: 383
Accident time: 07:54	Accident Date: 10/07/2002
Where it occurred: M/F 178, Bayt Yahun	Country: Lebanon
Primary cause: Unavoidable (?)	Secondary cause: Inadequate equipment (?)
Class: Excavation accident	Date of main report: 25/07/2002
ID original source: BOI:No006/2002	Name of source: MACC SL
Organisation: Name removed	
Mine/device: No.4 Israel AP blast / frag	Ground condition: grass/grazing area rocks/stones
Date record created: 22/02/2004	Date last modified: 23/03/2004
No of victims: 1	No of documents: 3

REPORT FOR ACCIDENT INVESTIGATION BOARD OF INQUIRY – No006/2002

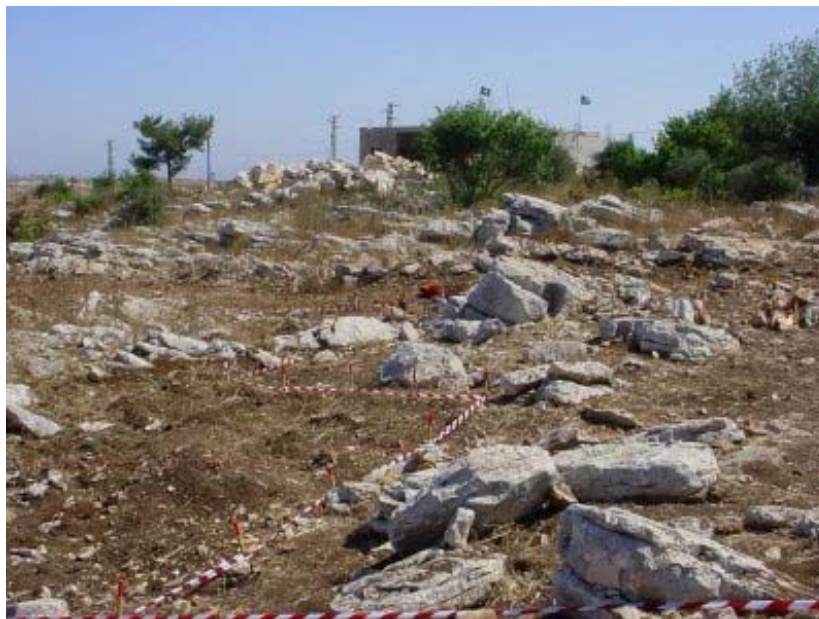
[The accident area.]

- There was a sub-surface detonation of an Israeli No.4 Anti Personnel mine. Evidence shows that the crater had heavy blackening to the sides, was of a bulbous shape with primary fragmentation lining the bottom and sides. Evidence of rock fracturing and shattering was located by the BOI, immediately behind the seat of detonation.

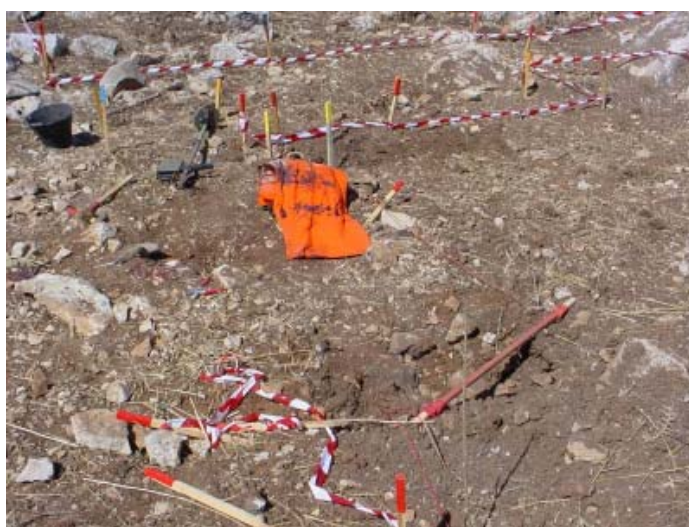
[The accident area after the detonation.]

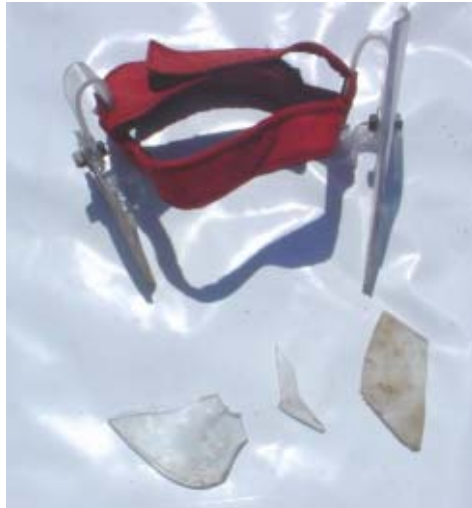
- The loss of the casualty's right eye was due to a piece of the visor slicing through the eye orbit, after the shattering of the visor.
- The visor shattered after being impacted with rock fragments at extremely high velocities following the detonation of the high explosives.

This was the third visor failure for this demining group in this country at this time and could indicate a possible problem with age or quality (polycarbonate hardens with UV exposure so old visors are much more likely to break than new ones). It is possible that the visor was struck by the handtool, or part of it, but it still should not have failed in this way. The visor was manufactured in Zimbabwe, and may have been part of the batch originally purchased three or four years previously. If so, UV exposure was a very likely cause of failure.

24. On inspection of parts of the protective visor, the following points were noted:

- The visor had not maintained its integrity and shattered into several pieces, of which on 3 pieces were located by the BOI.
- The visor securing bolts had maintained their integrity.

[The Victim's visor.]

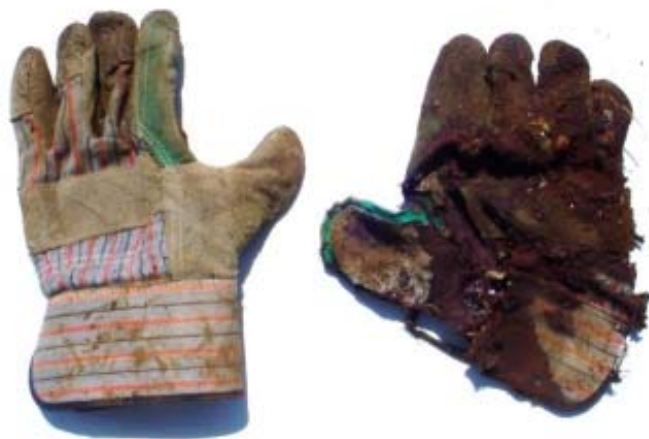
The Victim's gardening gloves are sometimes called PPE, but are not. They protect against ground scratches as the user works, but have provided no significant protection in those blast events when they have been worn.

25. On inspection of the demining gloves, the following points were noted:

- The right hand glove was ripped in several places, with a main tear in the location of the sleeve part of the thumb.
- No damage was sustained to the left hand glove.

[The Victim's gardening gloves.]
