### DDASaccident384

# DDAS Accident Report

<b>Report date:</b> 19/05/2006	<b>Accident number:</b> 384
<b>Accident time:</b> 13:20	<b>Accident Date:</b> 18/04/2002
<b>Where it occurred:</b> Kareza village, Mawat, Sharbazhier, Suleimanyah governorate	<b>Country:</b> Iraq
<b>Primary cause:</b> Unavoidable (?)	<b>Secondary cause:</b> Inadequate equipment (?)
<b>Class:</b> Excavation accident	<b>Date of main report:</b> 18/09/2002
<b>ID original source:</b> NPA/MAP/Adm/04-02	<b>Name of source:</b> ET:NPA
<b>Organisation:</b> Name removed	
<b>Mine/device:</b> Type 72 AP blast	<b>Ground condition:</b> grass/grazing area metal fragments
<b>Date record created:</b> 22/02/2004	<b>Date last modified:</b> 29/02/2004
<b>No of victims:</b> 1	<b>No of documents:</b> 1

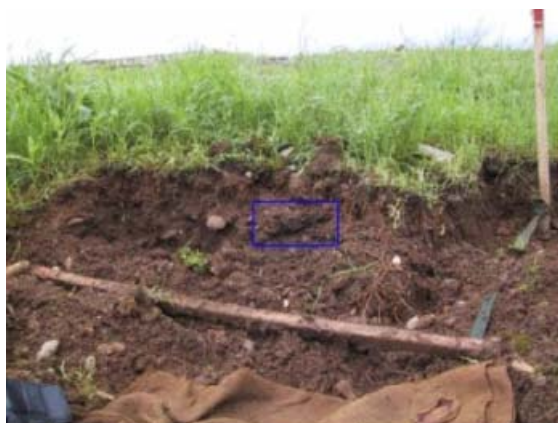
[The picture above shows the site of the accident.]

The lane starts with a slope to plane ground. Green grass, approx 25cm high, covered surface. The ground was wet due to the rain in the day before. All marking system and the clearance tapes were used correctly.

Only black mud and some small plastic pieces of the casing could be found in the explosion pit.

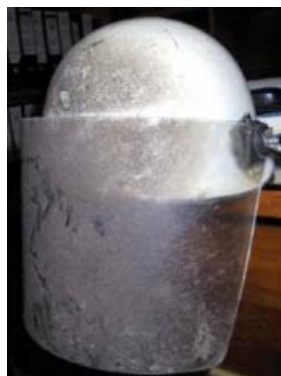
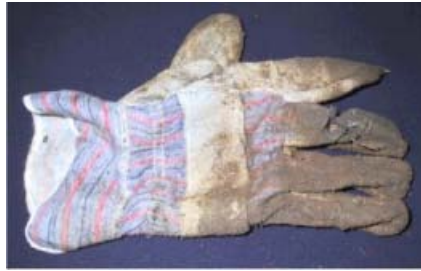
No penetration happened to the vest and the visor. The visor has very well protected the face and eyes.

The pictures below show the Victim's leather faced gardening glove and his helmet and visor.

The visor was perpendicular to the explosion pit. That didn't allow the pressure to lift up the visor and consequently the face and both eyes were kept safe.

Emphasis on wearing the safety equipment properly, visor in particular.

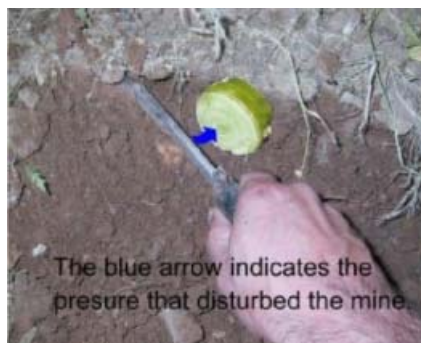
The bayonet was found at a 5m distance from the accident area. A slight bending indicates that the explosion hit the side of the bayonet.

Using right hand and excavating from the left to right of the base stick, this would likely allow generating pressure to uncleared area.

The bayonet didn't hit the mine directly, it pushed the earth and the earth disturbed the mine.

Handling the bayonet was as illustrated.

1-2 days refreshment for all the deminers and the field leaders as to manual drill and tools applying in excavation.

Revising the drill with bayonet.
