DDASaccident384

Humanitarian Demining Accident and Incident Database
AID

DDAS Accident Report

Report date: 19/05/2006	Accident number: 384
Accident time: 13:20	Accident Date: 18/04/2002
Where it occurred: Kareza village, Mawat, Sharbazhier, Suleimanyah governorate	Country: Iraq
Primary cause: Unavoidable (?)	Secondary cause: Inadequate equipment (?)
Class: Excavation accident	Date of main report: 18/09/2002
ID original source: NPA/MAP/Adm/04-02	Name of source: ET:NPA
Organisation: Name removed	
Mine/device: Type 72 AP blast	Ground condition: grass/grazing area metal fragments
Date record created: 22/02/2004	Date last modified: 29/02/2004
No of victims: 1	No of documents: 1

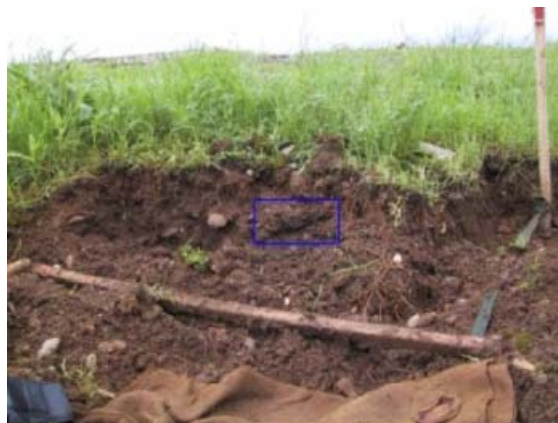
[The picture above shows the site of the accident.]

The lane starts with a slope to plane ground. Green grass, approx 25cm high, covered surface. The ground was wet due to the rain in the day before. All marking system and the clearance tapes were used correctly.

Only black mud and some small plastic pieces of the casing could be found in the explosion pit.

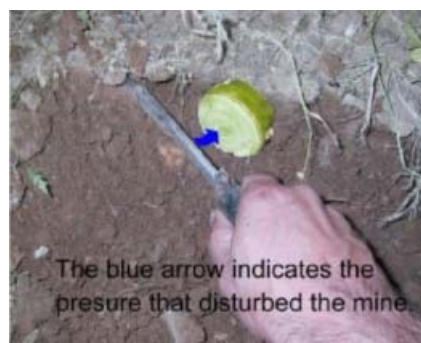
The bayonet was found at a 5m distance from the accident area. A slight bending indicates that the explosion hit the side of the bayonet.

Using right hand and excavating from the left to right of the base stick, this would likely allow generating pressure to uncleared area.

The bayonet didn't hit the mine directly, it pushed the earth and the earth disturbed the mine.

Handling the bayonet was as illustrated.

1-2 days refreshment for all the deminers and the field leaders as to manual drill and tools applying in excavation.

Revising the drill with bayonet.
