DDASaccident389

DDAS Accident Report

REPORT FOR ACCIDENT INVESTIGATION BOARD OF INQUIRY – No001/2003

DEMINING Accident that occurred in Arnoun on 12th January 2003 in which a [demining group]

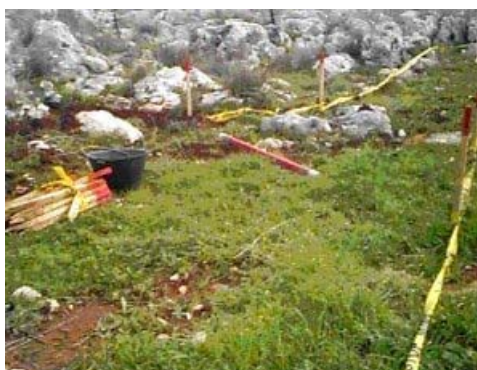
The picture below shows the accident site.

- There was a sub-surface detonation of the mine, evidence shows that the crater had heavy blackening to the sides, was of a bulbous shape and contained primary fragmentation.
