DDASaccident389

DDAS Accident Report

REPORT FOR ACCIDENT INVESTIGATION BOARD OF INQUIRY – No001/2003

DEMINING Accident that occurred in Arnoun on 12th January 2003 in which a [demining group]

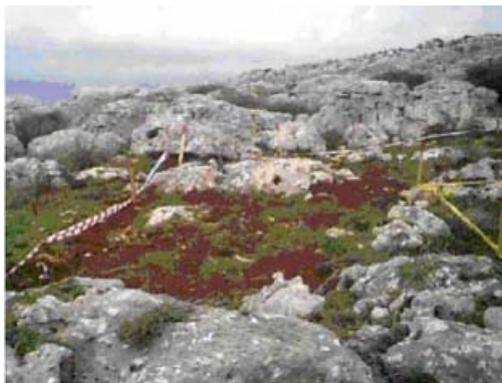
GENERAL VIEW OF THE AREA:

5. At the time of the accident [Demining group] Deminer [the Victim] was working in the first lane. The actual clearance lane was to the right hand side of the mine rows and due to the high level of metallic contamination in the ground the sapping method of clearance was being used.
6. From the start of the day's clearance activities (4 hrs 10 minutes had elapsed), [the Victim] had not located the mine. He then continued to extend the clearance lane approximately 1m whereupon he came across a rock to the left hand side of his lane marking rope. As the rock

would have been in the approximate location of the mine, he decided to clear around the rock. Prior to actually clearing around the rock, [the Victim] attempted to detect the mine with the detector, but due to the high level of metal contamination in the area he was unable to obtain an exact position of the mine.

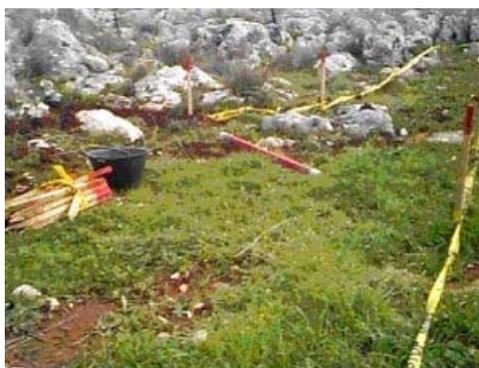
The picture below shows the accident site.

- There was a sub-surface detonation of the mine, evidence shows that the crater had heavy blackening to the sides, was of a bulbous shape and contained primary fragmentation.

- The vast majority of the blast effects were directed away from [2nd, inconsistent deminer name] due to his body position in relation to the direction that the detonating wave was travelling, the result being a 170 degree directional effect as opposed to a 360 degree omni-directional effect.

[Demining group] should introduce a probe and a lightweight excavation trowel procedure into their current SOPs. The International Deminers currently working for [Demining group] should have access to the full range of manual clearance tools and equipments that are available.

[Demining group] should strongly consider the introduction of the prone position when conducting the excavation drill into their current SOPs.

When the terrain permits and detailed information is known on the minefield lay out, clearance lanes should be ideally located on the side of the mine row where the rear part of the mine will be the first thing located during excavation.
