### DDASaccident390

# DDAS Accident Report

## **REPORT FOR ACCIDENT INVESTIGATION BOARD OF INQUIRY**

Demining Accident that occurred in MF 324 (NDO 253) on 11 of July 2003 in which [Demining group] DEMINER [The Victim] was injured.

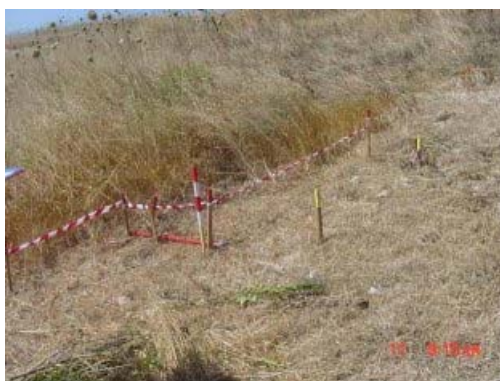
### **VIEW OF THE ACCIDENT SCENE**

There had been an uncontrolled surface detonation of a detonator. Probably it's a Gyata-64 detonator booster.

[The Victim] 's scissor had been in direct contact with the detonator booster at the time of detonation.

[The original report indicated that the detonation occurred in front of the base stick in the "cleared" area.]

The primary cause of this incident is listed as "Unavoidable" because it is not at all clear what the Victim initiated with his vegetation cutting shears. The photographs indicate that the detonation occurred behind the Victim's end-of-lane marking stick. It is not normal to move the stick forward before cutting the undergrowth and clearing the area with a metal-detector or excavation, so the device may have actually been "missed".

- No amendments are necessary to the National TSGs for Mine/UXO Clearance.
- One week of refresher\confidence training with all [Demining group] manual teams working in demining in Lebanon, the training is to include the following:
  - Mine Clearance Techniques i.e. Chapter 4 of TSGs and specially Para. 4.1 thru Para. 4.5.
  - As in this case of thick vegetation and to prevent accidents, the National TSGs allows burning the vegetation (Chapter 4, Para. 4.21), so we recommend using this method if it's suitable to be used (Supervisor decision).
  - Follow the Para. 4.22 Chapter 4 of TSGs which talks about working and break time in special weather and vegetation.
- The conclusion detailed in this report be distributed and discussed among all [Demining group] Operational Field Staff.

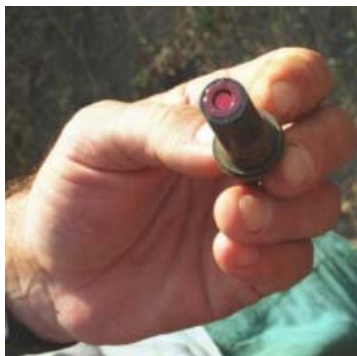
A booster from a GYATA-64 is a small bakelite cylinder with HE inside. At the centre of the HE is a stab-sensitive detonator. This is unlikely to be initiated by touching it, unless the end of the cutting shears probed into the end of the booster. A pin-pull fuze and detonator like that used in the Israeli No.4 AP mine may have been easier to initiate accidentally.

The picture above shows a GYATA-64 booster. The detonator is lacquered red.
