DDAS Accident Report

Report date: 19/05/2006	Accident number: 391
Accident time: 12:00	Accident Date: 10/05/2002
Where it occurred: OES 3, MF 147, Bayt Yahun	Country: Lebanon
Primary cause: Unavoidable (?)	Secondary cause: Inadequate equipment (?)
Class: Excavation accident	Date of main report: 16/05/2002
ID original source: Bol: No001/2002, MJF	Name of source: MACC SL
Organisation: Name removed	
Mine/device: No.4 Israel AP blast / frag	Ground condition: agricultural (abandoned) grass/grazing area
Date record created: 22/02/2004	Date last modified: 23/03/2004
No of victims: 1	No of documents: 2

REPORT FOR ACCIDENT INVESTIGATION BOARD OF INQUIRY – No001/2002

MINE Accident that occurred in OES 3 on 10 May 2002 in which [Demining group] Team Leader [name excised] was injured.

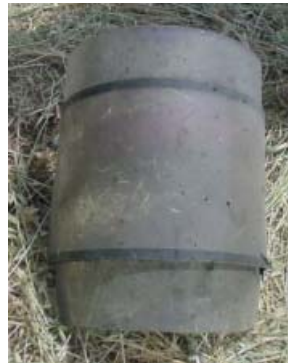
THE PROTECTIVE VISOR

28. On inspection of the protective visor, the following points were noted:

- A large proportion of the blast effects were concentrated on the outer face of the visor.
- There was part fragmentation penetration of the polycarbonate visor.
- There was no complete fragmentation penetration of the polycarbonate visor.

Blast effects across the face of the visor.

[The investigators interpreted the burned-out fragments pitting the visor face and scratch-guard as partial penetrations. No fragments penetrated fully.]

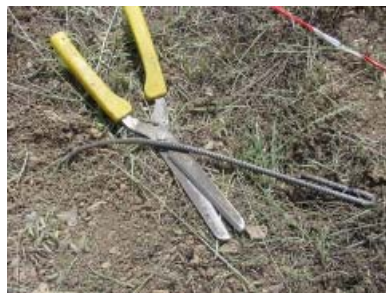
DEMINE PROBE USED BY TEAM LEADER

29. At the time of the accident, the only item of equipment that was being used was a standard [Demining group] metallic probe, one of 4 x different probes types currently used by [Demining group]. On inspection of the probe, the following points were noted:

- The end of the probe had bowed at an angle of approximately 110 degrees from the normal horizontal position.
- The tip of the probe had melted and become deformed.
- The probe was located at a distance of 2.15m from the seat of detonation.

[The picture above shows the bent probe with a burnt tip. It is made "candytwist" reinforcing bar and has been criticised in other theatres where this demining group works.]

- The end of the probe had bowed at an angle of approximately 110 degrees from the normal horizontal position due to the pressure generated during the detonation of the high explosive fill.
- The tip of the probe had melted and become deformed due to the extremely high temperatures generated on the detonation of the high explosive fill.

38. The BOI concludes that the most likely explanation why there was an uncontrolled detonation is that the base of the Israeli No4 AP mine was moved in an upward direction by the demining probe. This would have caused the release of the slotted striker retaining plate through counter-lever action, therefore allowing the spring-loaded striker to move forward and impinge on the detonator.

- In order for the tip of the probe to melt and deform, it must have been intimate contact with the mine prior to detonation.
- If the probing action had been taking place above the mine, the probe would have been located at a distance greater than 2.15m away [sic?]; the bowing and deformation of the probe would also not have been as substantial.
- The omni-directional blast effects, sub-surface levels are far higher and more concentrated than those on or near the surface.
- It was the downward movement of the probe, which caused the traumatic amputation of [the victim]'s thumb.

- No amendments are necessary to the National TSGs for Mine/UXO Clearance.
- A [Demining group] SOP covering the subject of “wetting of weather-hardened areas prior to the excavation of mines” is developed and submitted for approval to the MACC SL QA Section.
- All mines that prove be difficult to excavate or neutralise are to be destroyed in situ (by detonation only).
- The conclusions detailed in this report be distributed and discussed among all [Demining group] Operational Field Staff.
- A period of refresher / confidence training is conducted with all [Demining group] Operational Field Staff, to include the following subjects:
 - Manual probing and excavation techniques.
 - Manual neutralisation techniques of all in-country mines.

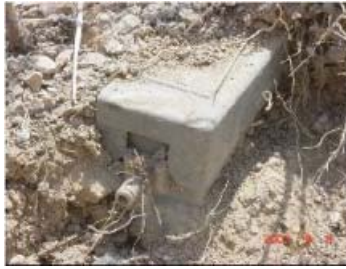
ISRAELI No.4 AP BLAST MINE

30. The Israeli No4 AP blast mine consists of a plastic box with a hinged lid that overlaps the sides. The main charge is 188g of cast TNT, housed in an internal plastic compartment, which occupies just over half of the volume of the box at the hinged end. The wall of this compartment is threaded to accept the fuze assembly; the remainder of the box is empty.

31. The metal fuze assembly, which incorporates a lead-shear arming delay, is fitted through a hole in the end of the mine and screwed into the wall of the charge compartment and sealed with a rubber O-ring. The arming pin protrudes through the end of the mine opposite the hinge. The arming pin is attached to a pull ring, which is looped over the fuze body and retained by a plastic cap during transit for additional safety. The striker is retained and secured by a square shaped slotted plate on which the open end of the box rests.

32. The mine is designed purely for direct pressure operation. To arm the mine, the plastic cap on the end of the fuze is removed to release the pull ring; the arming pin is then removed. The spring-loaded striker is retained until it has sheared through a lead wire, which runs through holes in the end of the fuze. The arming process normally takes several hours. Once armed, the striker is retained only by the slotted plate; pressure on the lid (in excess of 8kgs), simply pushes the slotted plate out which in turn releases the spring loaded central striker. The striker then impacts with the integral fuze detonator, which then passes the detonating wave to the main TNT charge causing the mine to disintegrate. (Paragraphs 30 – 32 inclusive extracted from Reference A)

33. There have been instances reported where foreign bodies have embedded themselves in between the recess in the striker mechanism and the slotted striker retaining plate, therefore allowing the partial downward release of the plate. The spring-loaded striker is now therefore only being held by the foreign body.

34. Accumulated pressure over a period of time (especially in heavy soil conditions), can also slowly release the slotted striker retaining plate. This therefore reduces the direct pressure required to activate the mine.

40. As explained previously (Para 33 & 34), it must also be noted that there is the possibility that the slotted striker retaining plate may not have been securely fitted around the spring-loaded striker through either foreign bodies being present or accumulated downward pressures over a period of time.

All mines that prove difficult to excavate or neutralise are to be destroyed in situ by demolition.

[Demining group] is also to provide MACC SL with a SOP amendment on manual neutralisation techniques for all mine types (incl Israeli No4).
