DDASaccident392

DDAS Accident Report

REPORT FOR ACCIDENT INVESTIGATION BOARD OF INQUIRY – No011/2002

DEMING Accident that occurred in OES 2 on 21st October 2002 in which [Demining group] Deminer [the Victim] was injured.

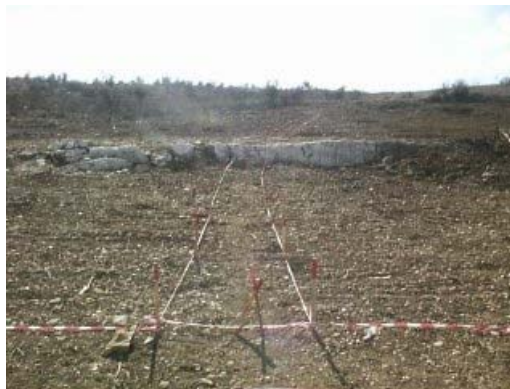
Minefield 358A [is shown below]. Showing the second access lane, previous flailed area and accident marking.

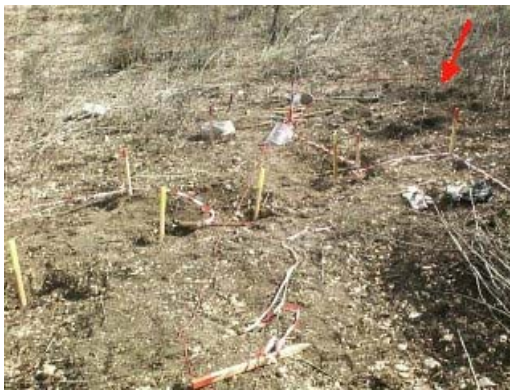
VIEW OF THE ACCIDENT SCENE FROM THE BASE LANE

[The accident scene following the accident. Marking is at best “confusing”. The seat of initiation is marked with a red arrow. Several other pictures of the site add little value and their overlay of explanatory lines became confused in file transfer, so they are omitted.]

- A. The uncontrolled detonation occurred when the Deminer marked a lane by knocking a red marking picket on top of the mine.
- B. There was a sub-surface detonation of an Israeli No4 enhanced Fragmentation Anti Personnel mine. The excavated craters radius was 90 cm and the depth 26 cm.
- C. At the time of the uncontrolled detonation, the mine would have been directly below the location of the marking picket; the deformation of the marking picket and [the victim]'s injuries substantiates this.

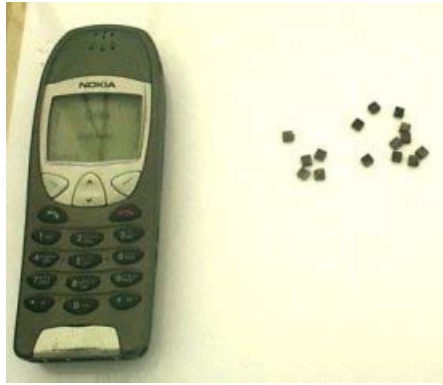
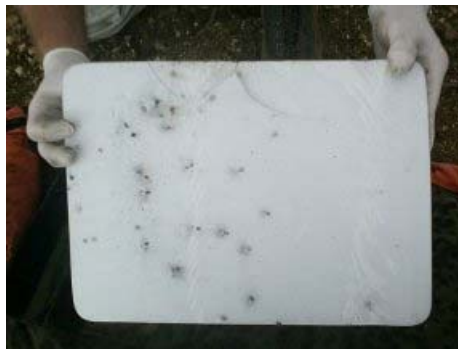
[The victim's] PROTECTIVE JACKET

33. At the time of the accident, [the victim] was wearing his protective apron and protective visor. On inspection of the protective apron, the following points were noted:

- The outer cover was ripped in several places.
- The blast debris and damage was concentrated on the left hand side.
- The polycarbonate chest plate was fractured in various places

[The apron worn by the victim has a cotton cover (for comfort) and this is usually damaged in any accident. The ballistic aramid inner is not Kevlar. To raise the protection offered in “vital areas” the apron has a small, optional polycarbonate insert in the chest area. In this case the insert was in place. It is shown below along with some of the 3mm square fragments of steel recovered from inside the armour. No fragments fully penetrated the armour or the visor.]

- P. The protective jacket maintained its integrity following the uncontrolled detonation of an Israeli No4 enhanced Fragmentation AP mine.
- Q. The protective visor maintained its integrity following the uncontrolled detonation of an Israeli No4 enhanced Fragmentation AP mine.

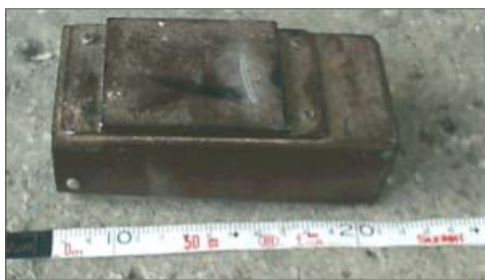
ISRAELI NO4 AP BLAST [and frag] MINE

40. The No 4 mine found in Mine Field 358 A is modified with a pre-cut fragmented metal plate that measures 7 cm x 6 cm x 4 mm. There is no information from IF why these particular No 4 Mines were enhanced with a metal plate. Upon detonation the metal plate fragments into small shrapnel approx 3 mm x 3 mm. All mines previously located in Mine field 358 A were of this model.

[This No.4 has a metal plate screwed to the lid – and behind the plate is a matrix of pre-cut fragments that turn the blast mine into a fragmentation mine.]

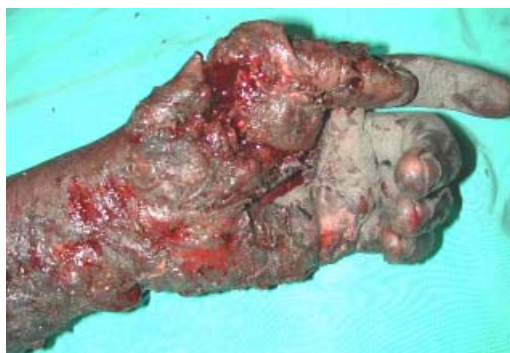
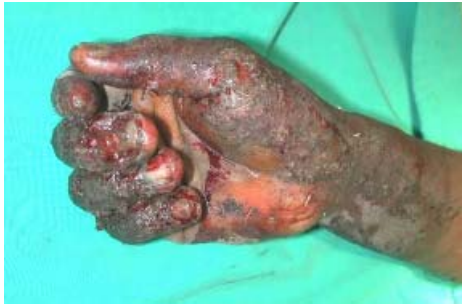
- Near total amputation of the left thumb (non viable) with open Thenar eminence and exposed metacarpal.
- Multiple shrapnel entries/burns over the palm of left hand, volar fingers and the forearm.
- Soft Tissue defect over the volar wrist 6 x 4 cm.
- Loss of the distal phalanx of the third digit of the left hand with preserved but macerated skin and soft tissues.
- Multiple burns/shrapnel entries over the dorsum of the distal fingers and palm of the right hand.
- Compound comminuted segment fractures of the Ulna and Radius in the left hand.
- Compartment syndrome of the left forearm.

Pictures of the victim's injuries allow some further assessment to be made.
