DDASaccident392

DDAS Accident Report

REPORT FOR ACCIDENT INVESTIGATION BOARD OF INQUIRY – No011/2002

DEMING Accident that occurred in OES 2 on 21st October 2002 in which [Demining group] Deminer [the Victim] was injured.

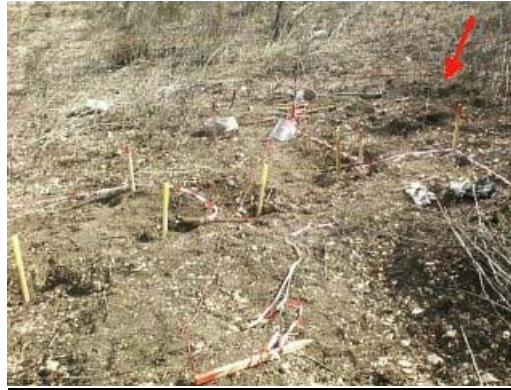
VIEW OF THE ACCIDENT SCENE FROM THE BASE LANE

[The accident scene following the accident. Marking is at best “confusing”. The seat of initiation is marked with a red arrow. Several other pictures of the site add little value and their overlay of explanatory lines became confused in file transfer, so they are omitted.]

- A. The uncontrolled detonation occurred when the Deminer marked a lane by knocking a red marking picket on top of the mine.
- B. There was a sub-surface detonation of an Israeli No4 enhanced Fragmentation Anti Personnel mine. The excavated craters radius was 90 cm and the depth 26 cm.
- C. At the time of the uncontrolled detonation, the mine would have been directly below the location of the marking picket; the deformation of the marking picket and [the victim]'s injuries substantiates this.

- A. The Clearance Team is suspended for a period of 7 x working days for refresher training.
- B. Marking picket should only be inserted in areas that have been previously cleared.

- C. All demining lanes should be marked in accordance with current SOPs by the deminer who clears that lane.
- D. Team Leaders are not to clear mines but to concentrate on leading and supervising team deminers.

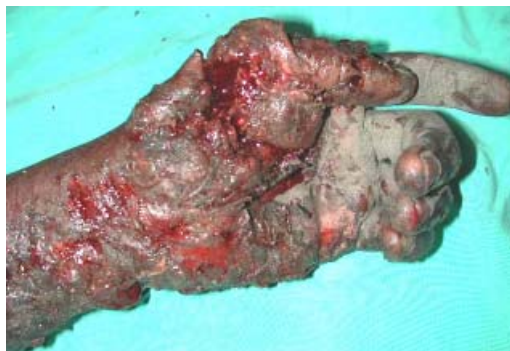
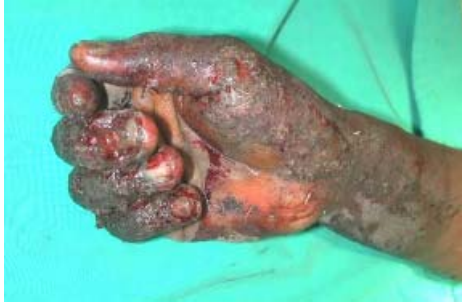
- Near total amputation of the left thumb (non viable) with open Thenar eminence and exposed metacarpal.
- Multiple shrapnel entries/burns over the palm of left hand, volar fingers and the forearm.
- Soft Tissue defect over the volar wrist 6 x 4 cm.
- Loss of the distal phalanx of the third digit of the left hand with preserved but macerated skin and soft tissues.
- Multiple burns/shrapnel entries over the dorsum of the distal fingers and palm of the right hand.
- Compound comminuted segment fractures of the Ulna and Radius in the left hand.
- Compartment syndrome of the left forearm.

Pictures of the victim's injuries allow some further assessment to be made.
