DDAS Accident Report

Report date: 19/05/2006	Accident number: 393
Accident time: 07:36	Accident Date: 21/09/2002
Where it occurred: MF: 466, Jabal Balat	Country: Lebanon
Primary cause: Unavoidable (?)	Secondary cause: Inadequate equipment (?)
Class: Excavation accident	Date of main report: 08/01/2003
ID original source: Bol: 009/2002: MJF	Name of source: MACC SL
Organisation: Name removed	
Mine/device: No.4 Israel AP blast / frag	Ground condition: bushes/scrub electromagnetic grass/grazing area rocks/stones
Date record created: 23/02/2004	Date last modified: 17/03/2004
No of victims: 1	No of documents: 1

REPORT FOR ACCIDENT INVESTIGATION BOARD OF INQUIRY – No009/2002

DEMING Accident that occurred in OES 1 on 21st September 2002 in which [Demining group] Deminer [name excised] was injured.

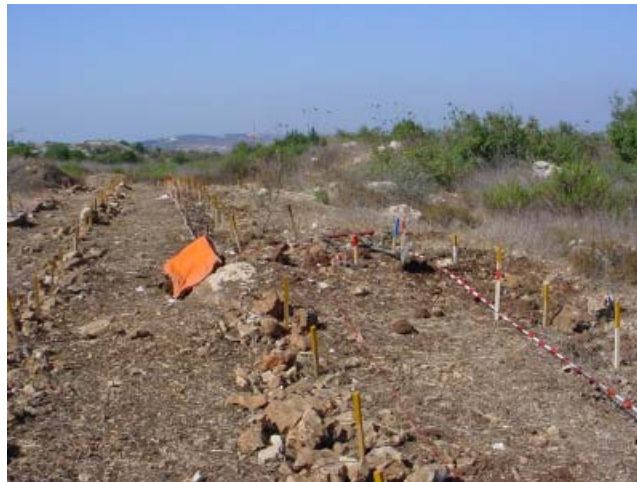
Lane "C" M/F 466 is the one on the right in the picture above.

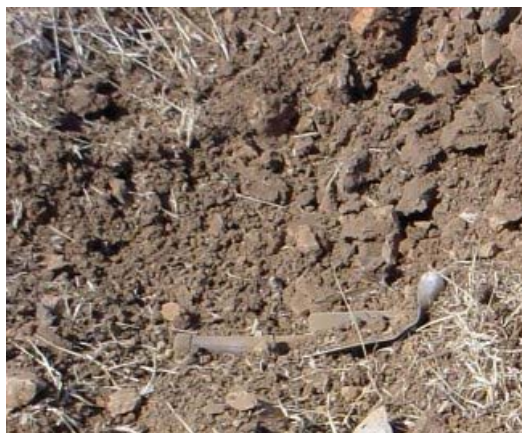
12. On arrival at the accident scene in lane "C", due to the effects of the detonation wave the BOI could only gain safe access up to the daily work marker (blue picket), the BOI therefore only initially conducted the investigation to that point. A request was then made to utilise [Demining group] demining assets to clear forward of the blue picket along the original clearance lane, a distance of approximately 2m in order to gain access to the seat of detonation and the demining trowel, this request was granted and the requested area cleared.

[The picture above shows the crater and the damaged trowel.]

- E. There was a sub-surface detonation of the mine, evidence shows that the crater had heavy blackening to the sides, was of a bulbous shape and contained primary fragmentation.

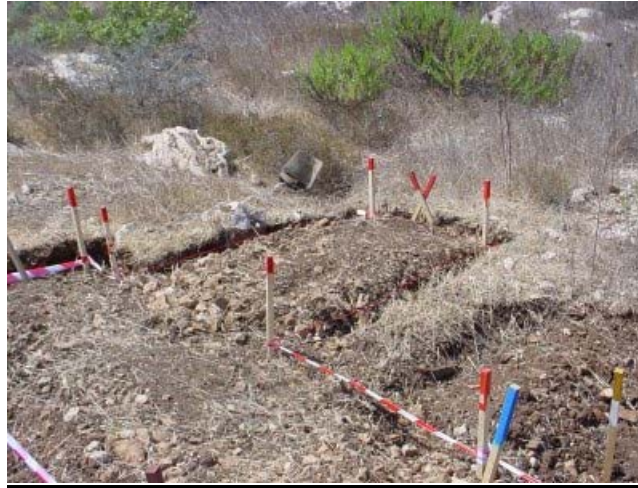
VIEW SHOWING THE SECOND BOI REQUESTED CLEARED AREA

[The picture above shows how the area looked after it had been cleared and marked for the Bol team. The clarity of the marking contrasts greatly with the pictures taken immediately after the accident. The visor is in both, so helping to identify what has been done.]

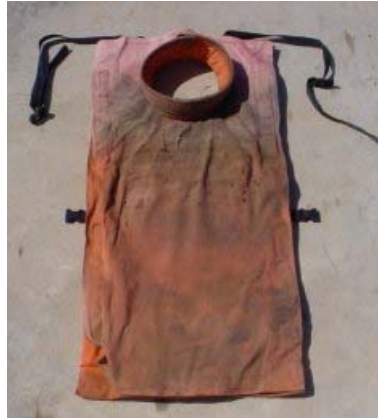
VIEW SHOWING DEMINER'S PROTECTIVE JACKET

27. At the time of the accident, [the Victim] was wearing his protective apron and protective visor. On inspection of the protective apron, the following points were noted:

- The outer cover had been torn in several places by secondary fragmentation.
- The inner polycarbonate plate pocket material had been torn by secondary fragmentation.
- The inner polycarbonate plate had spoil deposits on it (secondary fragmentation disintegration).
- The blast debris and damage was concentrated in the centre of the jacket.
- There was fragmentation penetration of the Kevlar lining.

[The apron's cotton cover was torn. The polycarbonate chest insert was marked by disintegrated fragments (dust) but not damaged.]

- M. The BOI agrees with and accepts [Demining group] Accident and IMSMA Reports, in particular the conclusion detailed at Para 4.5 (PPE and medics).
- N. The protective jacket maintained its integrity following the uncontrolled detonation of an Israeli No4 AP mine.

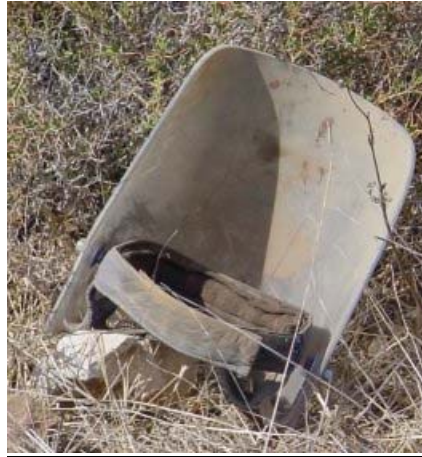
VIEW SHOWING PROTECTIVE VISOR

28. On inspection of parts of the protective visor, the following points were noted:

- The visor face had maintained its integrity.
- There was secondary fragmentation damage to the centre of the visor face, but no fragmentation penetration.
- The visor securing bolts had maintained their integrity.

- O. The protective visor maintained its integrity following the uncontrolled detonation of an Israeli No4 AP mine.
- P. The use of a demining probe to investigate signals, in conjunction with a more lightweight demining trowel may reduce the risk of any uncontrolled detonations occurring. When used correctly, Deminers have a tangible and physical indication of any hidden object prior to any excavation actually being undertaken.
- Q. Deminers adopting the prone position when investigating signals will minimise the injuries sustained, should an uncontrolled detonation occur.
- R. Paragraph 4.19 to Chapter 4 of National TSGs does not cover in sufficient details the action to be taken when clearing around rocks.

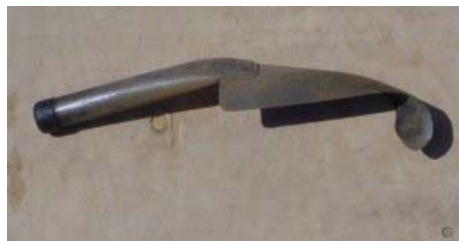
VIEW SHOWING EXCAVATION TROWEL

30. On inspection of the trowel, the following points were noted:

- The trowel tip (last third of the blade), had been deformed quite considerably.
- There was a small crease on the underside of the trowel, 13cm from the blade / handle joint.
- There was heavy blackening confined to the second third of the trowel blade, around the location of the small crease as detailed above.

[This trowel is made in Zimbabwe and featured in several accidents there. In two cases, it caused severe injury to the user, in one case the injuries resulted in death. The inadequacy of the trowel has been observed before.]

- C. The mine functioned when the bottom side of the demining trowel pushed down on the plastic lid of the mine. This in turn would have released the slotted striker retaining plate and subsequently released the cocked striker mechanism. Evidence to substantiate this conclusion are detailed below:

- The small crease on the underside of the trowel, 13cm from the blade / handle joint was part of the trowel that was in intimate contact with the mine lid when the mine detonated. The crease formed on the detonation of the high explosive fill.

- The trowel tip had deformed quite considerably because this is the weakest part of the trowel and the part of the trowel that would have been closest to the mine main explosive fill when it detonated.

- The heavy blackening confined to the second third of the trowel blade (around the location of the small crease), is a residual effect of detonating high explosives.

- a. [Demining group] should introduce a probe and a lightweight excavation trowel procedure into their current SOPs. The International Deminers currently working for [Demining group] should have access to the full range of manual clearance tools and equipments that are available.
