DDAS Accident Report

Report date: 19/05/2006	Accident number: 393
Accident time: 07:36	Accident Date: 21/09/2002
Where it occurred: MF: 466, Jabal Balat	Country: Lebanon
Primary cause: Unavoidable (?)	Secondary cause: Inadequate equipment (?)
Class: Excavation accident	Date of main report: 08/01/2003
ID original source: Bol: 009/2002: MJF	Name of source: MACC SL
Organisation: Name removed	
Mine/device: No.4 Israel AP blast / frag	Ground condition: bushes/scrub electromagnetic grass/grazing area rocks/stones
Date record created: 23/02/2004	Date last modified: 17/03/2004
No of victims: 1	No of documents: 1

REPORT FOR ACCIDENT INVESTIGATION BOARD OF INQUIRY – No009/2002

DEMING Accident that occurred in OES 1 on 21st September 2002 in which [Demining group] Deminer [name excised] was injured.

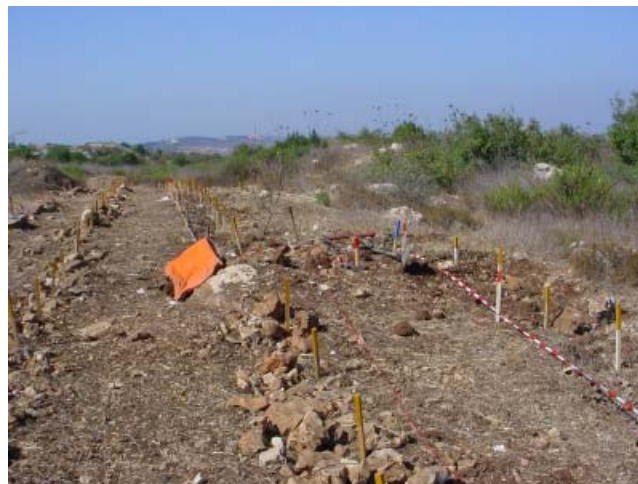
Lane "C" M/F 466 is the one on the right in the picture above.

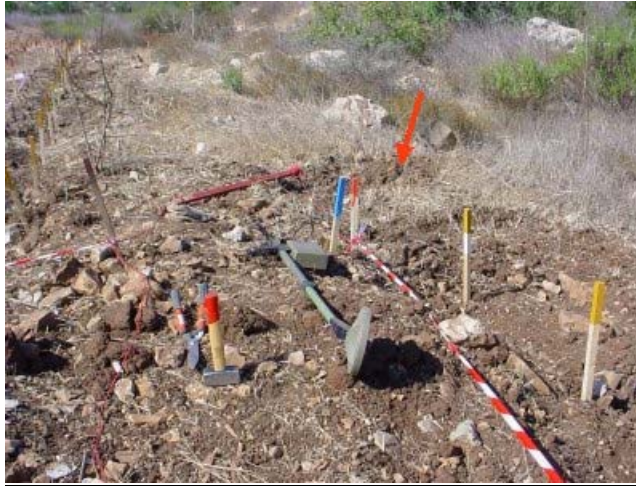
[The seat of initiation is shown by the red arrow in the picture above. Note inadequate marking.]

- E. There was a sub-surface detonation of the mine, evidence shows that the crater had heavy blackening to the sides, was of a bulbous shape and contained primary fragmentation.

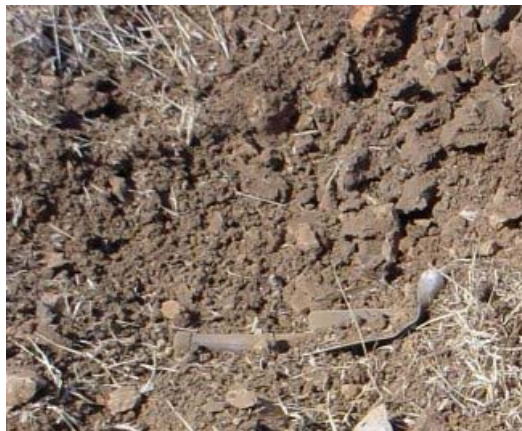
[The picture above shows the crater and the damaged trowel.]

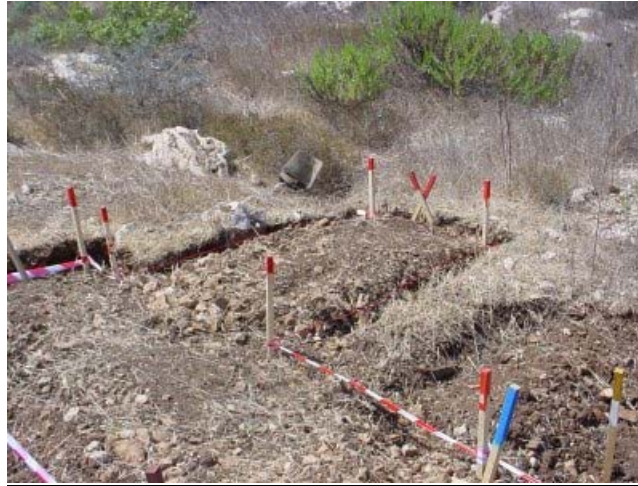
VIEW SHOWING THE SECOND BOI REQUESTED CLEARED AREA

[The picture above shows how the area looked after it had been cleared and marked for the Bol team. The clarity of the marking contrasts greatly with the pictures taken immediately after the accident. The visor is in both, so helping to identify what has been done.]

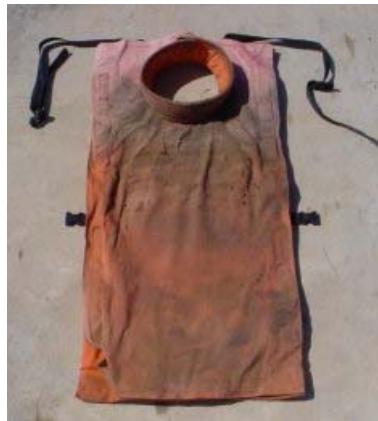
VIEW SHOWING DEMINER'S PROTECTIVE JACKET

27. At the time of the accident, [the Victim] was wearing his protective apron and protective visor. On inspection of the protective apron, the following points were noted:

- The outer cover had been torn in several places by secondary fragmentation.
- The inner polycarbonate plate pocket material had been torn by secondary fragmentation.
- The inner polycarbonate plate had spoil deposits on it (secondary fragmentation disintegration).
- The blast debris and damage was concentrated in the centre of the jacket.
- There was fragmentation penetration of the Kevlar lining.

[The apron's cotton cover was torn. The polycarbonate chest insert was marked by disintegrated fragments (dust) but not damaged.]

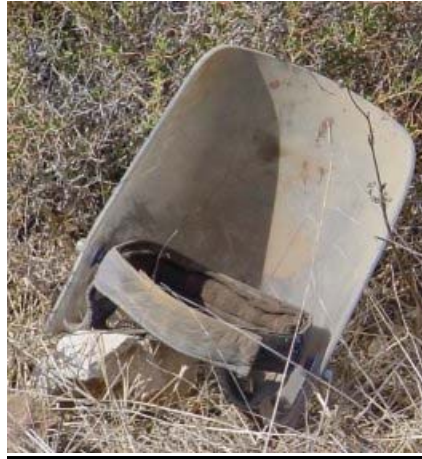
VIEW SHOWING PROTECTIVE VISOR

28. On inspection of parts of the protective visor, the following points were noted:

- The visor face had maintained its integrity.
- There was secondary fragmentation damage to the centre of the visor face, but no fragmentation penetration.
- The visor securing bolts had maintained their integrity.

- O. The protective visor maintained its integrity following the uncontrolled detonation of an Israeli No4 AP mine.
- P. The use of a demining probe to investigate signals, in conjunction with a more lightweight demining trowel may reduce the risk of any uncontrolled detonations occurring. When used correctly, Deminers have a tangible and physical indication of any hidden object prior to any excavation actually being undertaken.
- Q. Deminers adopting the prone position when investigating signals will minimise the injuries sustained, should an uncontrolled detonation occur.
- R. Paragraph 4.19 to Chapter 4 of National TSGs does not cover in sufficient details the action to be taken when clearing around rocks.

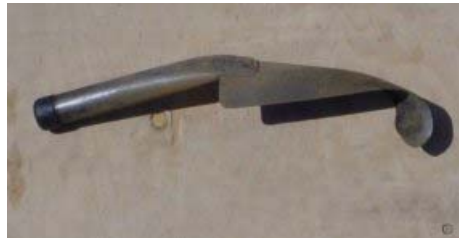
VIEW SHOWING EXCAVATION TROWEL

30. On inspection of the trowel, the following points were noted:

- The trowel tip (last third of the blade), had been deformed quite considerably.
- There was a small crease on the underside of the trowel, 13cm from the blade / handle joint.
- There was heavy blackening confined to the second third of the trowel blade, around the location of the small crease as detailed above.

[This trowel is made in Zimbabwe and featured in several accidents there. In two cases, it caused severe injury to the user, in one case the injuries resulted in death. The inadequacy of the trowel has been observed before.]

- C. The mine functioned when the bottom side of the demining trowel pushed down on the plastic lid of the mine. This in turn would have released the slotted striker retaining plate and subsequently released the cocked striker mechanism. Evidence to substantiate this conclusion are detailed below:

- The small crease on the underside of the trowel, 13cm from the blade / handle joint was part of the trowel that was in intimate contact with the mine lid when the mine detonated. The crease formed on the detonation of the high explosive fill.

- The trowel tip had deformed quite considerably because this is the weakest part of the trowel and the part of the trowel that would have been closest to the mine main explosive fill when it detonated.

- The heavy blackening confined to the second third of the trowel blade (around the location of the small crease), is a residual effect of detonating high explosives.

The “inadequate equipment” referenced under “notes” refers to the demining trowel in use, and the lack of a probe. The “trowel” was used as a sole probing/excavating tool and has featured in several accidents in this database. It’s inappropriate design has caused severe injuries to several users and it may well have contributed to the injuries sustained in this accident.

- a. [Demining group] should introduce a probe and a lightweight excavation trowel procedure into their current SOPs. The International Deminers currently working for [Demining group] should have access to the full range of manual clearance tools and equipments that are available.

The recommendation of the BOI, paragraph 38 a, is strongly supported. The company should introduce the use of the mine probe as a part of the basic demining tool kit and instruct their deminers in the correct use of this tool as soon as possible.
