DDASaccident394

DDAS Accident Report

REPORT FOR ACCIDENT INVESTIGATION BOARD OF INQUIRY – No002/2002
MINE Accident that occurred in OES 3 on 13th May 2002 in which [Demining group] Deminer [the Victim] was injured.
Map Reference: UNIFIL Genimap 1:50,000 Sheet A (Tibnin).
References: A. Janes Mines Manual.

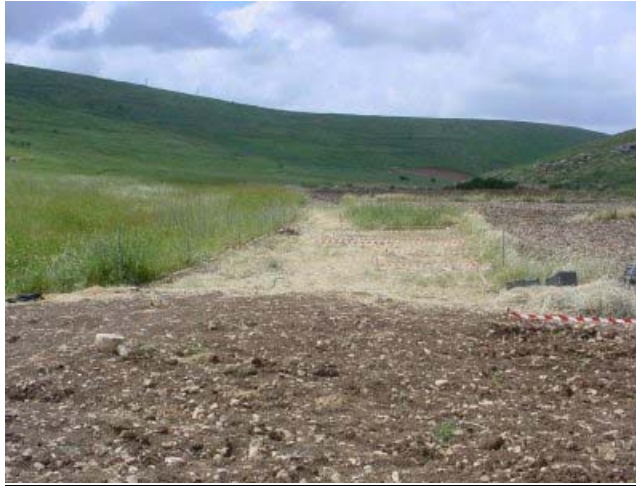
VIEW OF M/F501 - GENERAL AREA

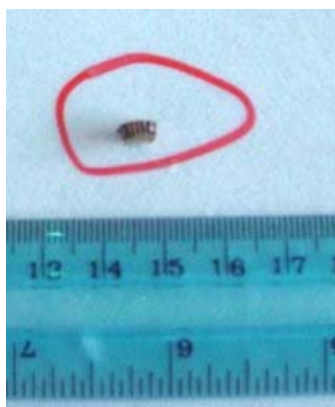
20. [The victim] suffered deep fragmentation lacerations to the insides and tip of his left hand middle, ring and index fingers, a minor closed fracture of his left hand middle two fingers and a deep laceration on the inside of his left hand thumb. There was also a small minor fragmentation laceration to [his] right hand palm. [Demining group] Survey Team Medic administered medical treatment and stabilisation on-site to [the victim] (wound dressings and intravenous "Ringer" solution); casualty evacuation by road to Bint Jubayl civilian hospital then took place.

FRAGMENTATION RECOVERED FROM LEFT HAND THUMB

- [The victim] injuries were sustained from the primary fragmentation, resulting in the part disintegration of the Israeli No4 mine fuze, on the detonation of the primary high explosives fill.

The photograph of a fragment removed from his hand is further evidence that the injuries were serious.
