DDASaccident395

DDAS Accident Report

REPORT FOR ACCIDENT INVESTIGATION BOARD OF INQUIRY – No010/2002
MINE Accident that occurred in OES 3 on 26th September 2002.
Map Reference: UNIFIL Genimap 1:50,000 Sheet A (Tibnin).

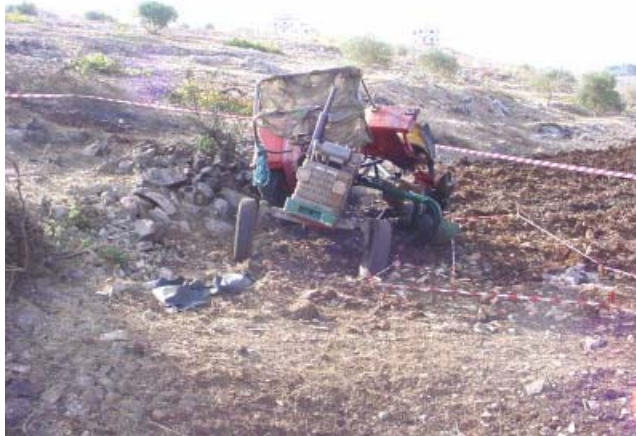
PHOTOGRAPH SHOWING THE ACCIDENT AREA

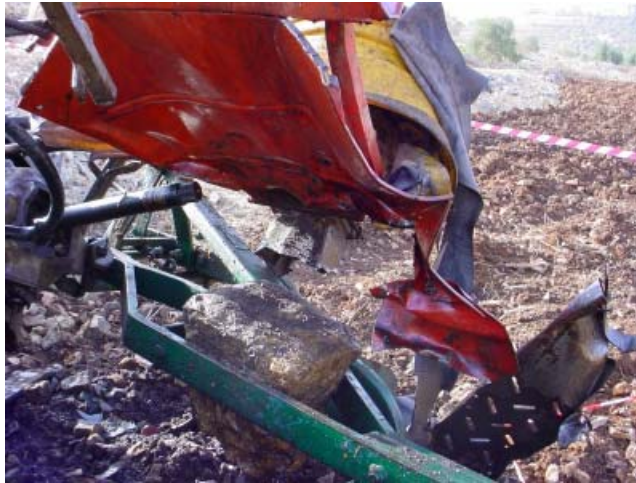
[Photograph showing the damage to the tractor wheel (the wheel hub was yellow).]

- e. The detonation occurred when the tractor driven by [the victim]. Drove over the location of the said TM-46 AT mine, with the detonation occurring directly under the tractor's back left hand wheel.

- g. The tractor was lifted and moved approximately 2m to the North East following the uncontrolled detonation.
 - h. The Mine Accident AT crater was located inside a previously cleared [Demining group] MDD area that had been physically marked and included in the Completion Report.

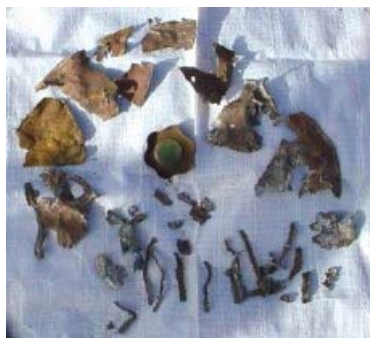
8. At 0630 hrs on the 27th September 2002, [Demining group] EOD Team commenced clearance to the seat and around the seat of detonation and at 0745 hrs clearance was completed. Once the clearance had been completed, the BOI excavated the crater and primary fragment remnants of a TM-46 Anti Tank (AT) mine were recovered. No actual explosive items were located by the EOD Team or the BOI during the clearance.

PHOTOGRAPH SHOWING RECOVERED MINE FRAGMENTS

19. Based on the Accident Investigation the following is concluded:
- a. There was a sub-surface detonation of a TM-46 (fuzed MV-5), AT mine.
 - b. The crater measured 48cm deep and 70cm wide, with large quantities of TM-46 primary fragmentation lining the sides and bottom the crater. 50% of the crater showed signs of a bulbous effect (heavy soil area), no bulbous effects was shown in the other 50% of the crater due to rocky ground.

- c. Based on the above conclusion, it is estimated that the TM-46 AT mine detonated at a depth of 300mm / 350 mm below the surface.
 - d. The TM-46 AT mine may have been originally laid by Palestinian forces and not Israeli forces.
